Environmental Impact Assessment

Emerald Beach and Pelican Beach Nourishment and Stabilization PR 15234

Emerald and Pelican Beach Owners Group
Turks and Caicos Islands

Revised May 2022

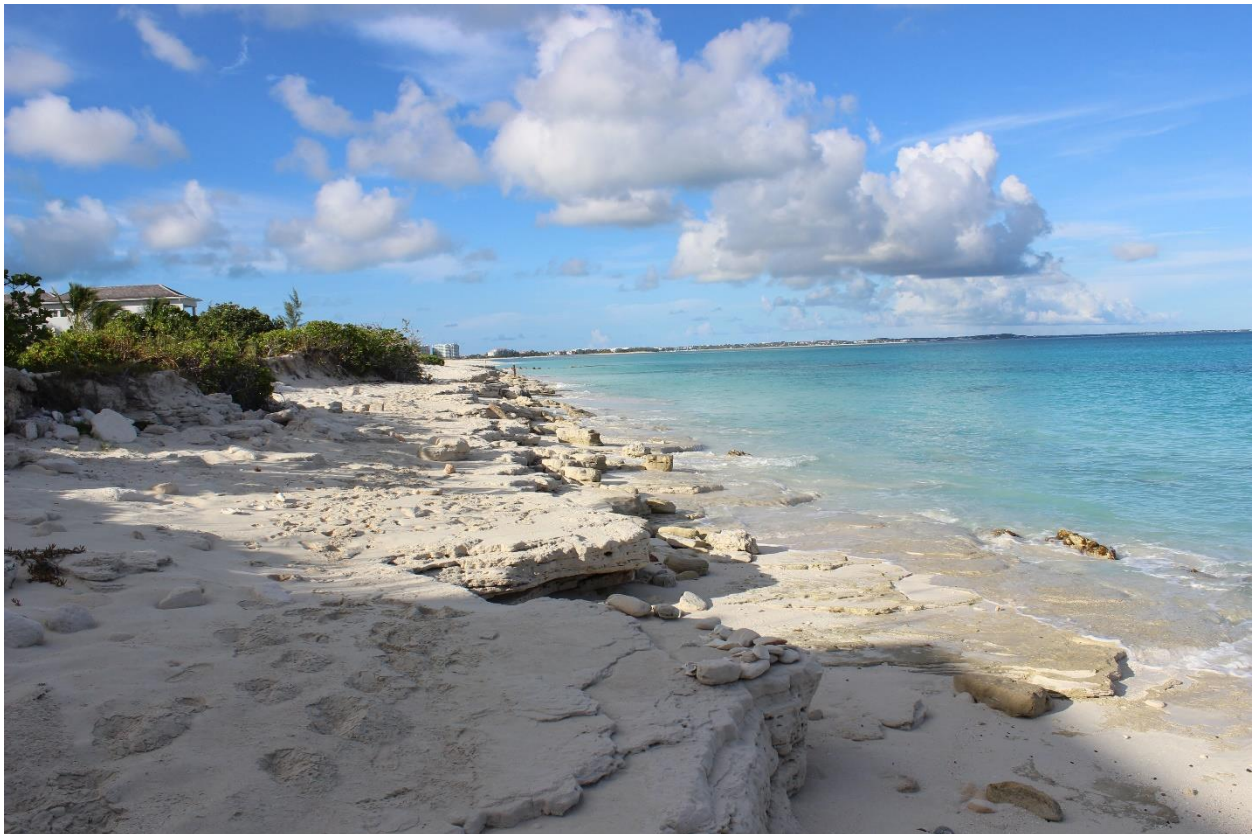
Approximately 1.17 acres (6.8% of the assessment area) was found to consist of consolidated substrate in the form of naturally occurring slabs of rock pavement, previously constructed seawalls and rock groynes. This community was generally devoid of terrestrial vegetation. Marine organisms adapted for life on rock substrates in the inter-tidal zone (e.g., knobby littorina/beaded periwinkles (*Cenchritus muricatus*), chitons (*Acanthopluera granulata*), nerites (*Nerita* spp.) were occasionally present where these habitats were present in the inter-tidal zone, as described in the results of the baseline marine assessment. Photo 2-1, Photo 2-2 and Photo 2-3 are representative of this community type.

Photo 2-1. Naturally occurring slabs of Rock Pavement. View looking west
Date of Photo: September 28, 2021

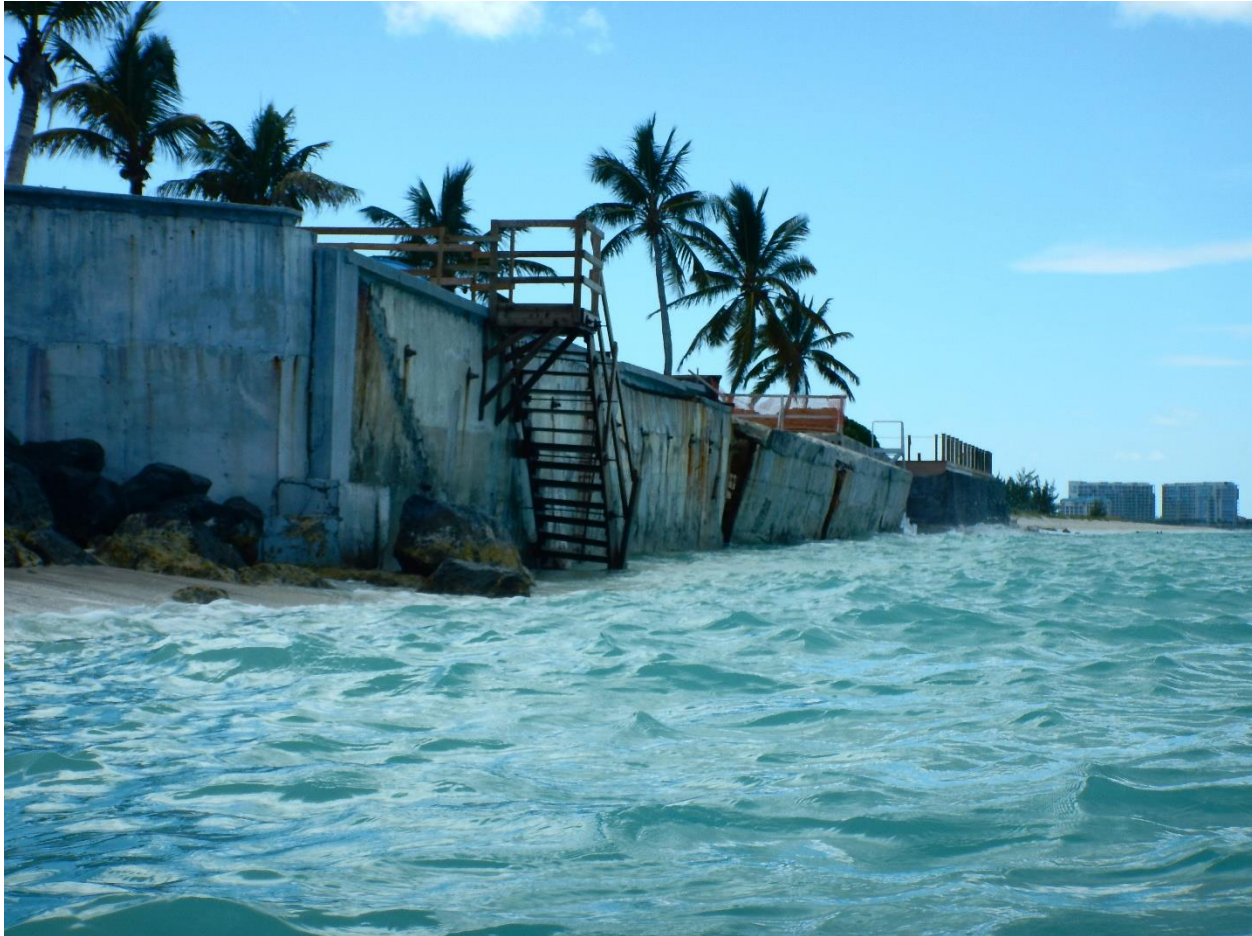
Along two stretches, 242 metres (794 feet) and 55 metres (180 feet) respectively, vertical seawalls were directly exposed to sea (Photo 2-2). Terrestrial vegetation was non-existent on the seawalls.

Photo 2-2. Vertical Seawalls. View looking southwest
Date of Photo: September 29, 2021

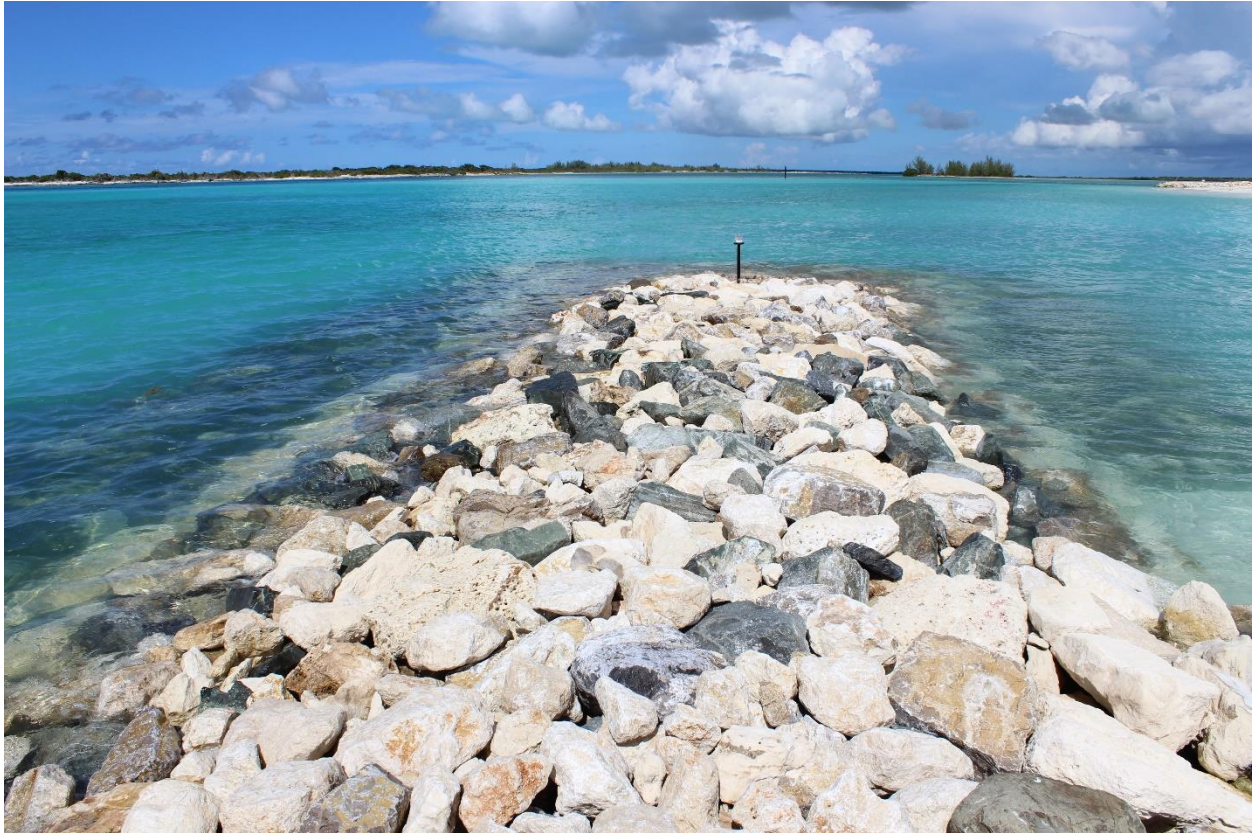
The highest elevation portions of the easternmost, recently constructed groyne appeared to be potentially suitable for the future existence of a terrestrial vegetative community (Photo 2-3), but no plants had become established.

**Photo 2-3. Uppermost areas of Rock Groyne. View looking northeast.
Date of Photo: September 28, 2021**

This community was mostly in Poor condition, due to it being an artificially created substrate nearly totally devoid of existing native flora and fauna. This community does, however, provide structural value for coastal resiliency and protection from storms and potential effects of sea level rise.

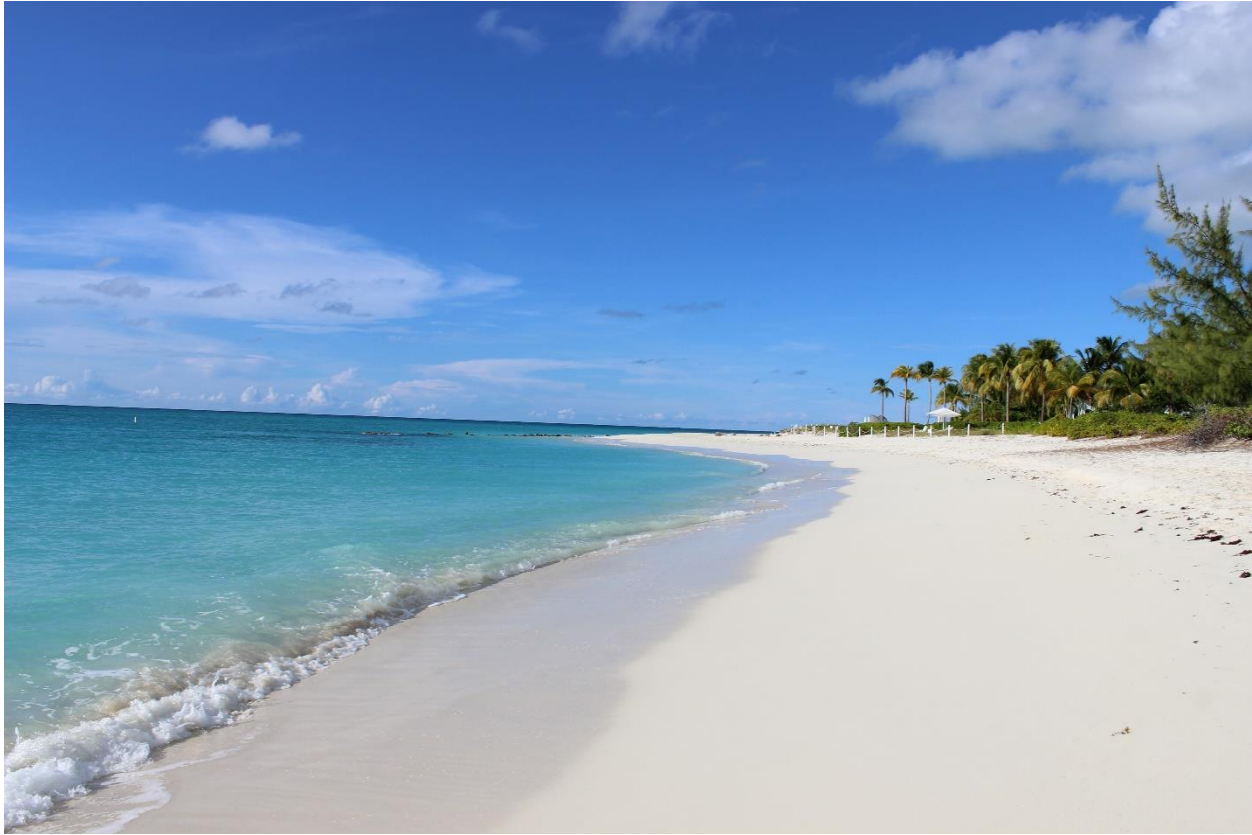
**Photo 2-4. Barren Sandy Beach. View looking Northeast.
Date of Photo: September 27, 2021**

Approximately 9.46 acres (57.8% of the assessment area) was found to consist of non-vegetated sandy beach, much of which was either within normal or intermittent tidal inundation or situated slightly landward of mean high water (Photo 2-4).

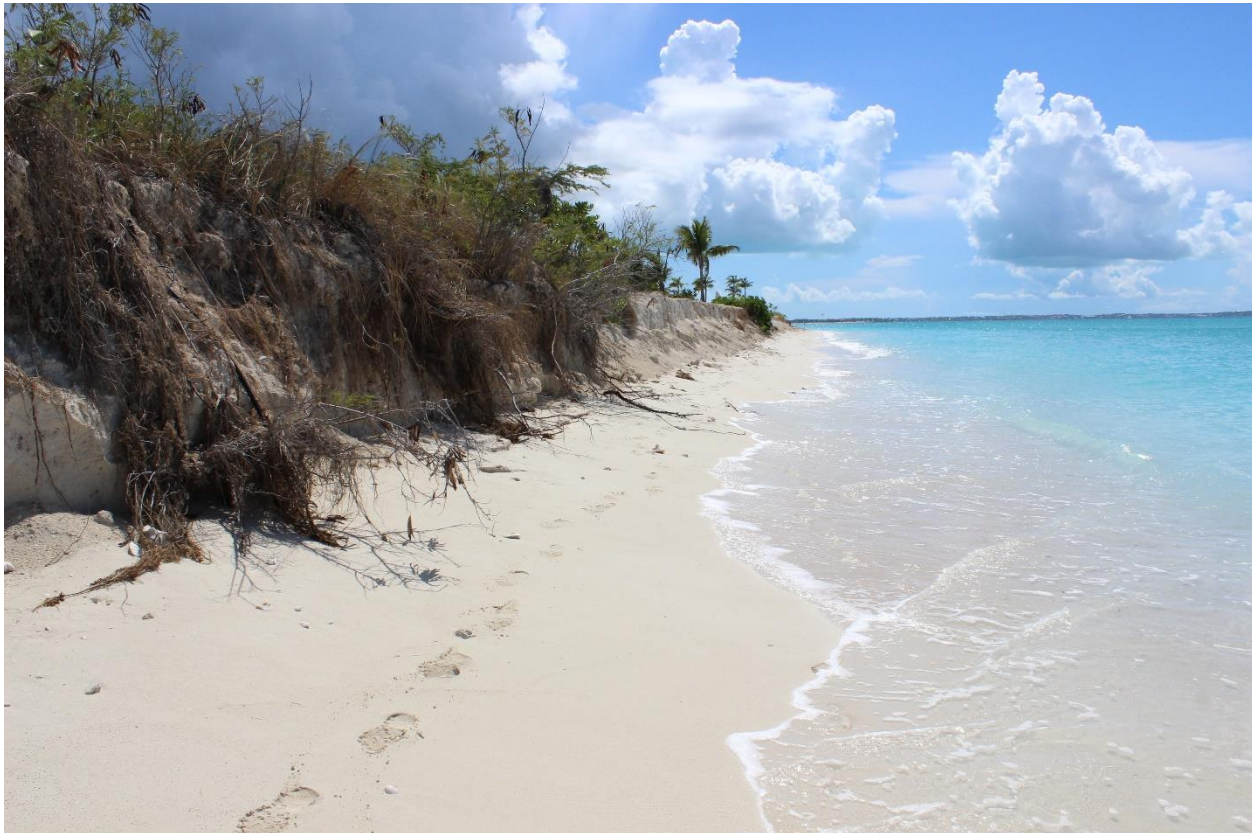
This community was ranked as being in Good or Poor condition at varying locations along the 2.25 kilometre length of the assessment area. Beach width varied from less than 6 metres (about 18 feet) to approximately 40 metres (about 125 feet). The upper limit of this community transitioned into pioneer-zone vegetation species (e.g., sea oats – *Uniola paniculata*), which appeared to likely have been previously planted. Portions of this community were heavily eroded, as evidenced by a steep escarpment, where previously occurring sand strand vegetation was eroding due to sea/wave action. Photo 2-6 is representative of conditions in this area.

Photo 2-6. Example of heavily eroded upper portion of Sandy, Un-vegetated Beach. View looking west. Date of Photo: September 28, 2021

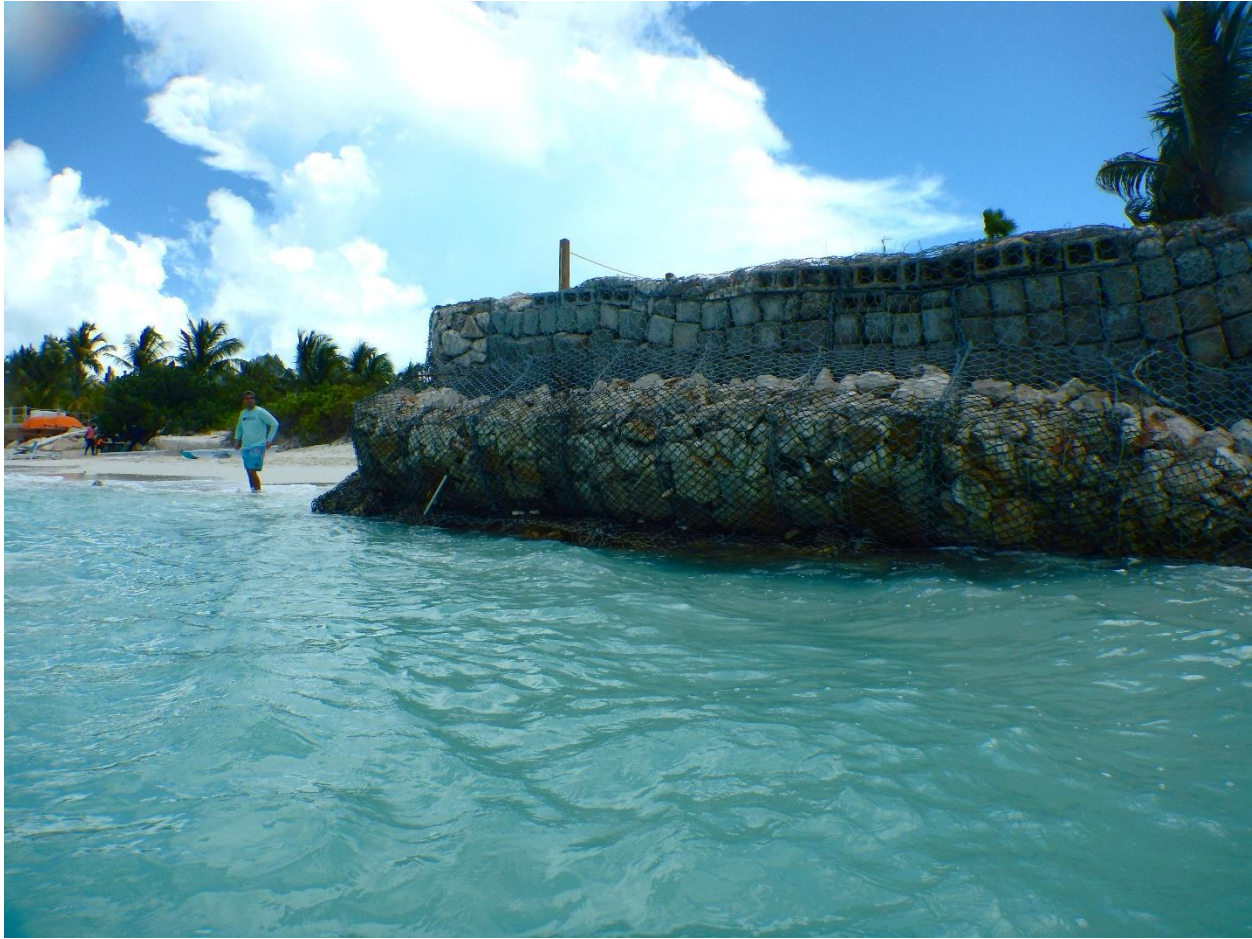
Approximately 297 metres (974 feet) of the shoreline consisted of seawalls with no appreciable beach. The condition of the walls is in general poor, with evidence of active failure of significant portions of the walls (Photo 2-12).

**Photo 2-12. Vertical Seawalls. View looking southwest
Date of Photo: September 29, 2021**

In some places rip-rap has been placed at the toe of the seawall to provide toe scour protection to the wall (Photo 2-12).

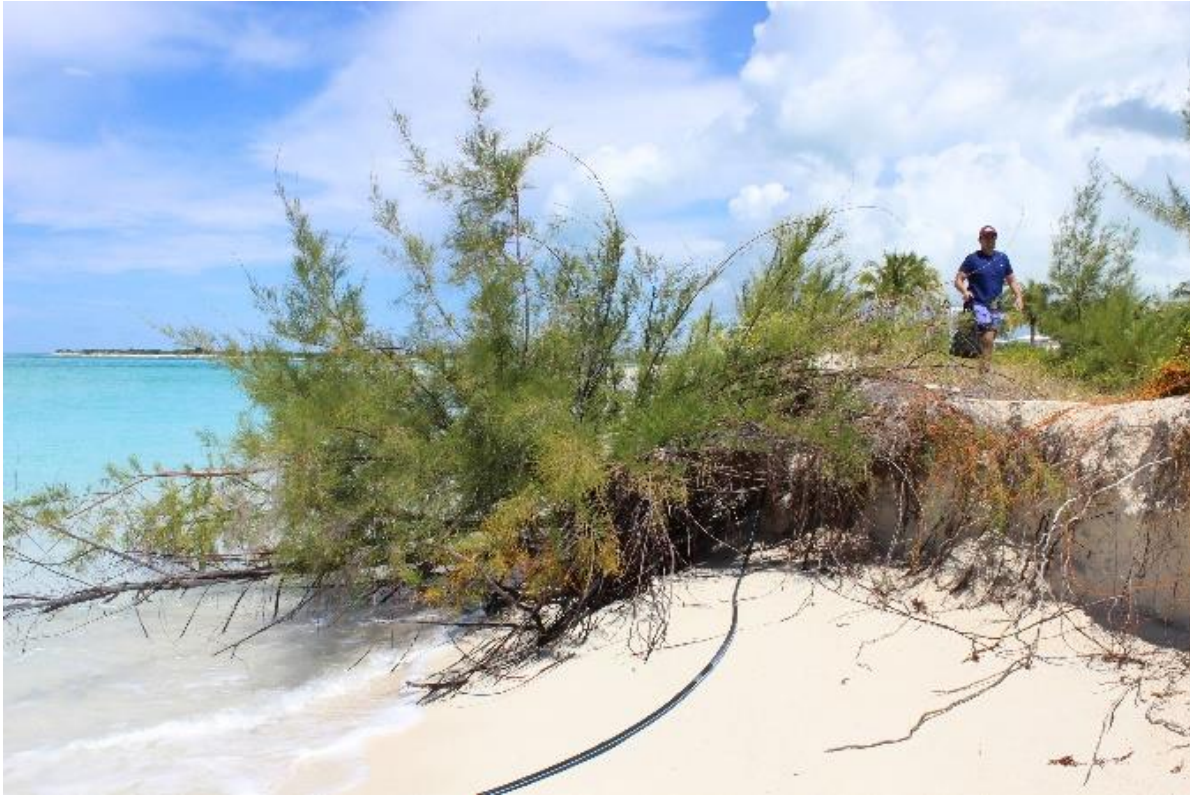
The topography of the project site primarily consists of a narrow beach which extends from the shoreline landward to a dune system or seawall that varies in elevation from 2 metres to 3 metres above mean sea level. Along Emerald Beach there is severe erosion from high seas and waves resulting in vertical cliffs from the top of dune to the high tide line. Along Pelican Beach sections of the shoreline were fortified with seawalls that have begun to fail. There is currently no beach along the seawalls. Significant losses of sand along the Emerald and Pelican Beaches occurred due to the passing of Hurricanes Irma and Maria in 2017 (Photo 2-20) (Photo 2-21).

Photo 2-20. Erosion along Emerald Beach

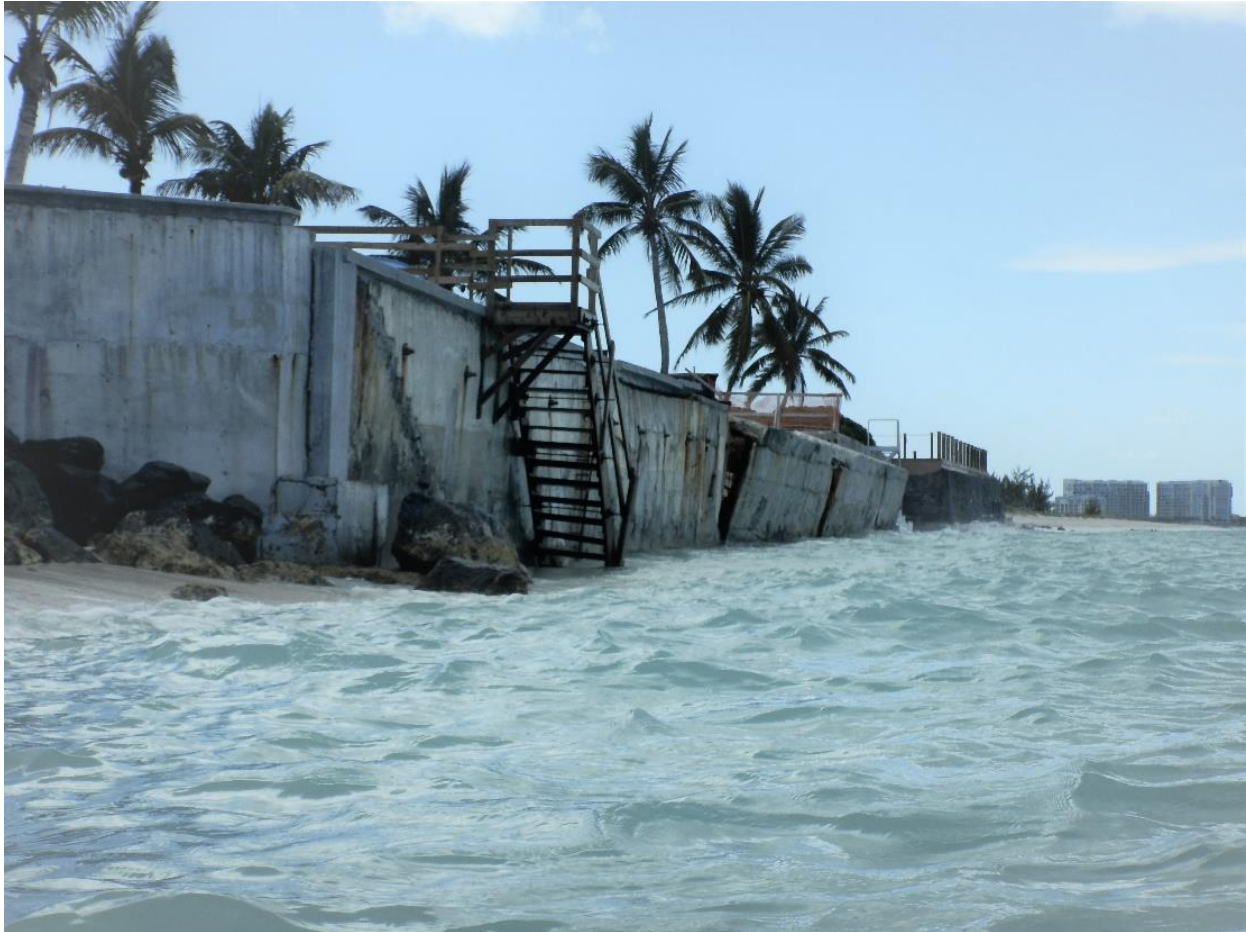
Photo 2-21. Seawalls along Pelican Beach

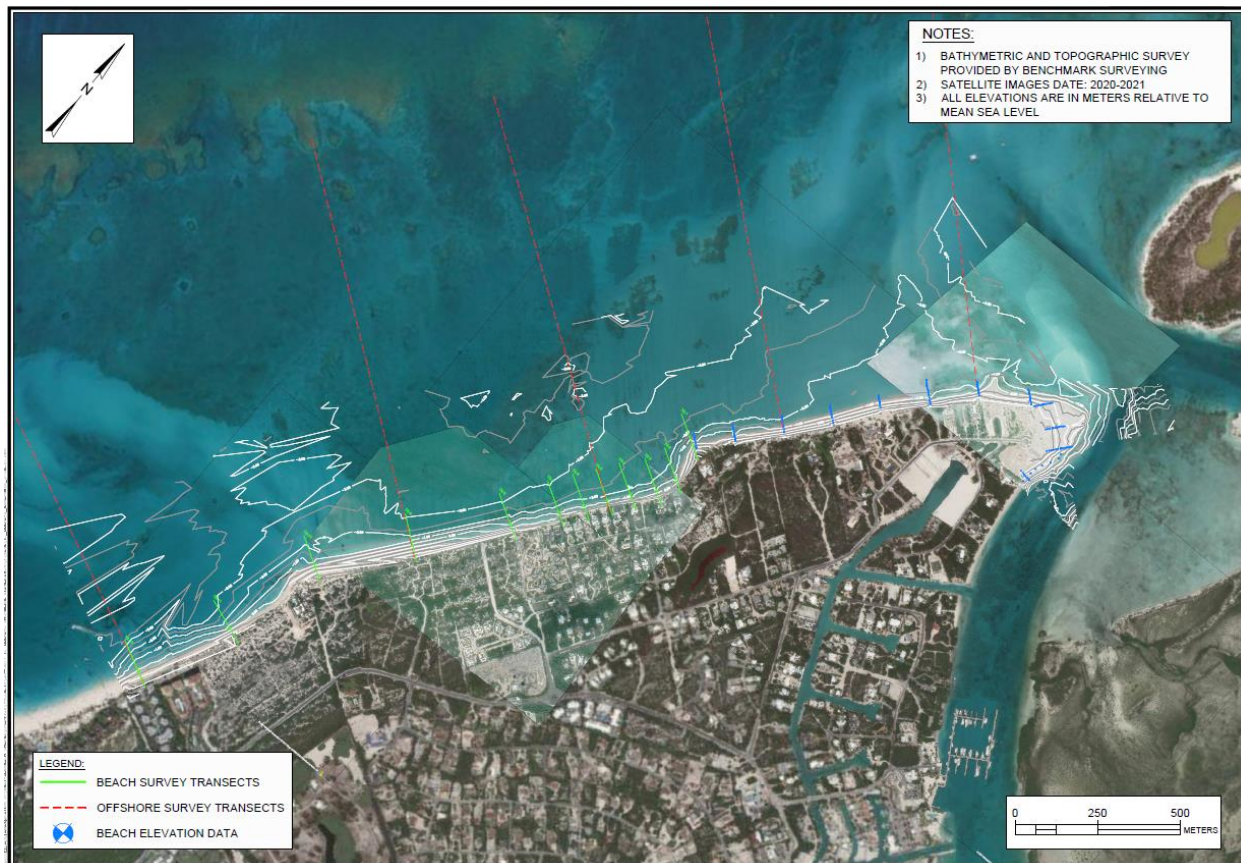
Figure 2-5. Survey Plan Lines and Contours

During September-October 2021, ATM appointed a local contractor, Benchmark Surveying, to conduct a beach cross-section survey at the project site from Emerald Beach to Grace Bay. Survey lines were spaced nominally 150 feet apart along Emerald Beach. Survey lines were spaced closer together along Pelican Beach from Pelican Point groyne through the seawall section of the beach. Survey cross-section locations and contours are presented in Figure 2-5 (Appendix D).

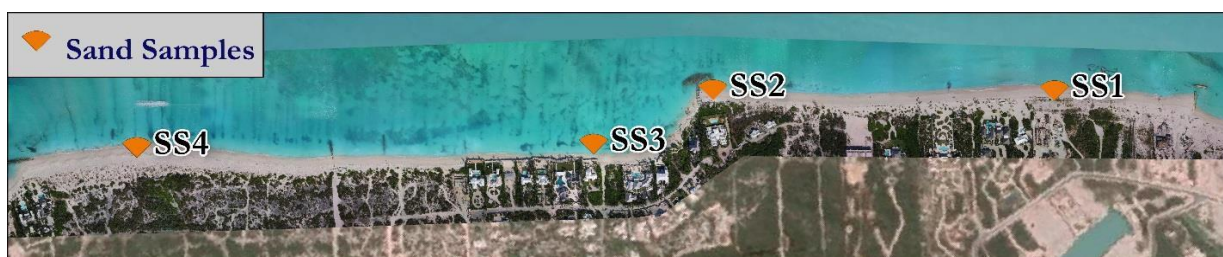
Figure 2-6. Sand sample locations

The sediment present on a coast may be used to provide insight when assessing the coastal processes and is an important component of the aesthetics and comfort of the beach or coastal zone. During a 2018 study (Appendix E2), four samples were taken along the Leeward coastline as shown in Figure 2-6. Samples SS2 and SS3 were taken in the swash zone and sample SS1 and SS4 were taken on the sand dunes. These samples were sent to a geotechnical lab to be visually inspected, air dried and subjected to a standard dry sieve analysis to determine their grain size distribution as well as other characteristic parameters. The results are summarized in Table 2-7.

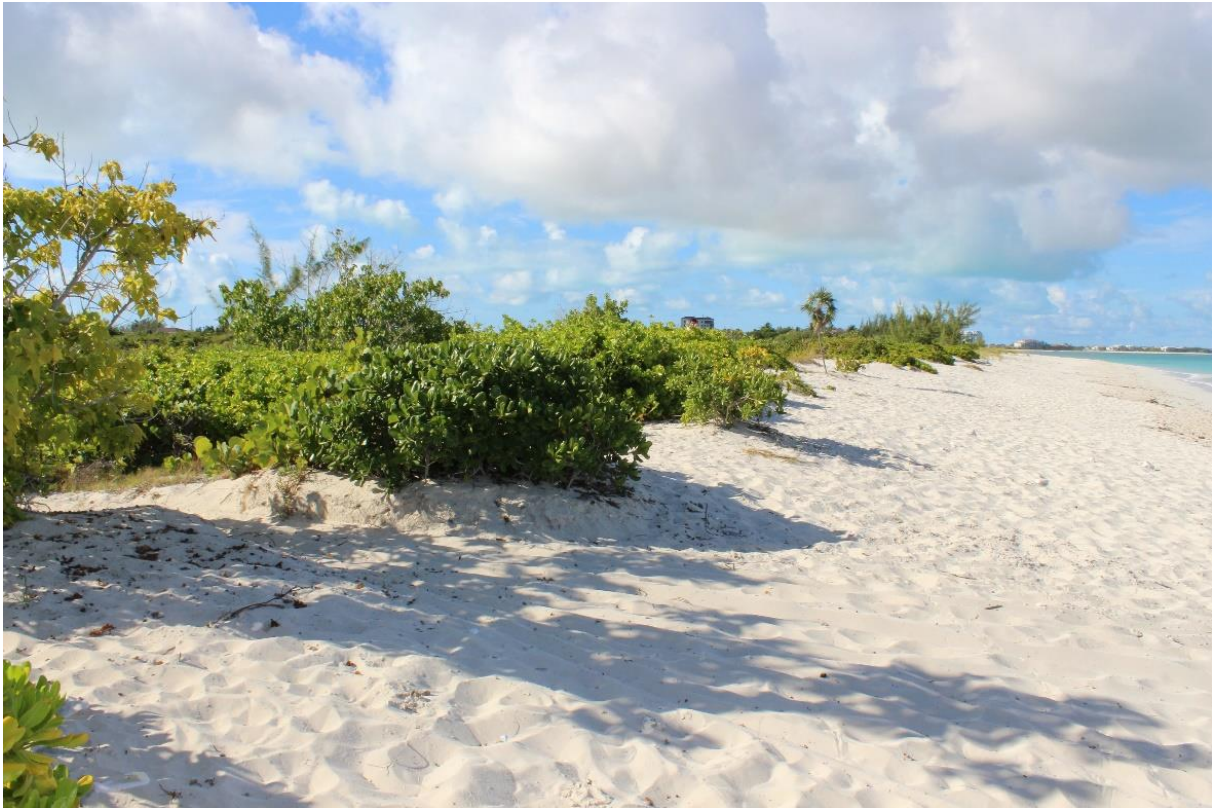
Photo 2-22. Natural aesthetics of existing beach will be preserved

The aesthetics of the shoreline will remain natural. Sand placement will retain a natural grade terminating at the current vegetation line of the dune or, in the cases of private property/seawalls, to an elevation consistent with neighbouring properties (Photo 2-22).

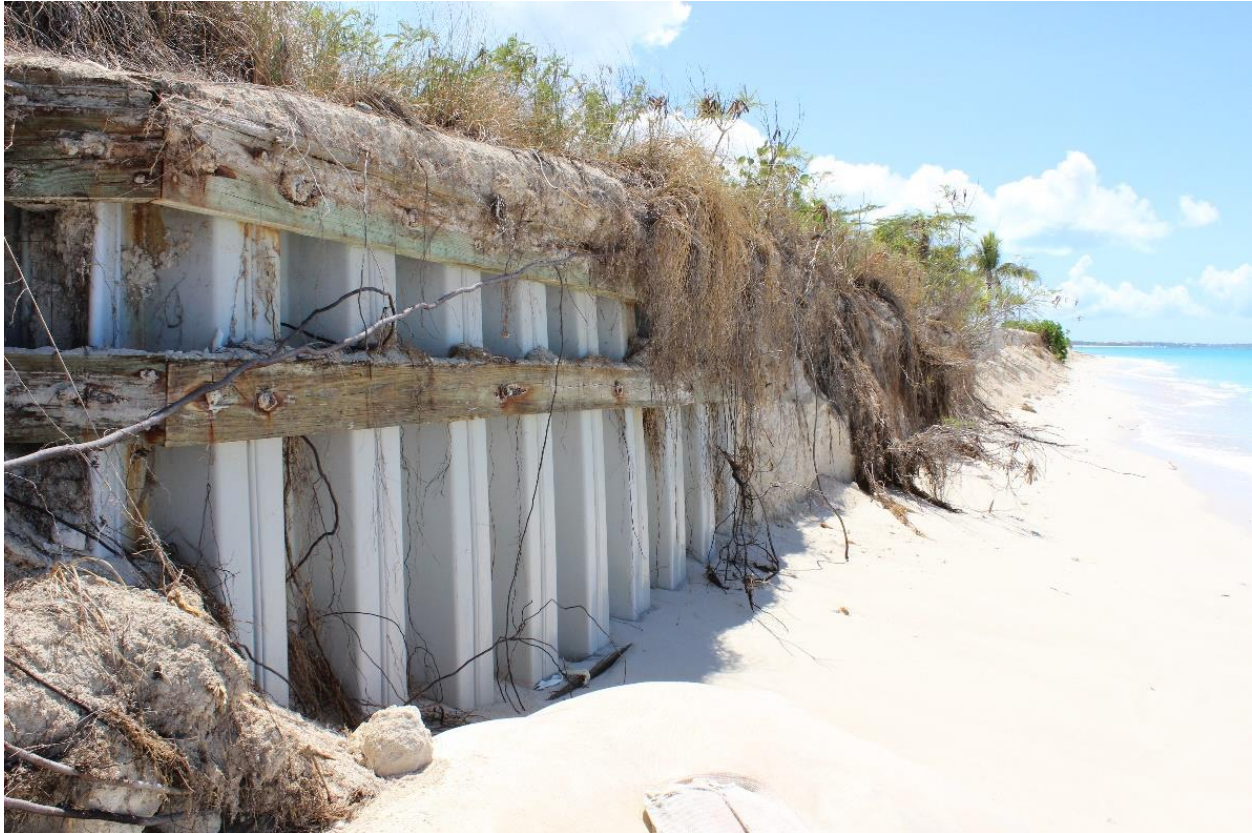
Photo 2-23. Beach sand placement and encouraged planting of dune vegetation will enhance the aesthetics of eroded areas.

No formal landscaping plan is included in this project however, homeowners should be encouraged to plant beach stabilizing native species in the upper part of the beach, and remove invasive exotic species (Photo 2-23).

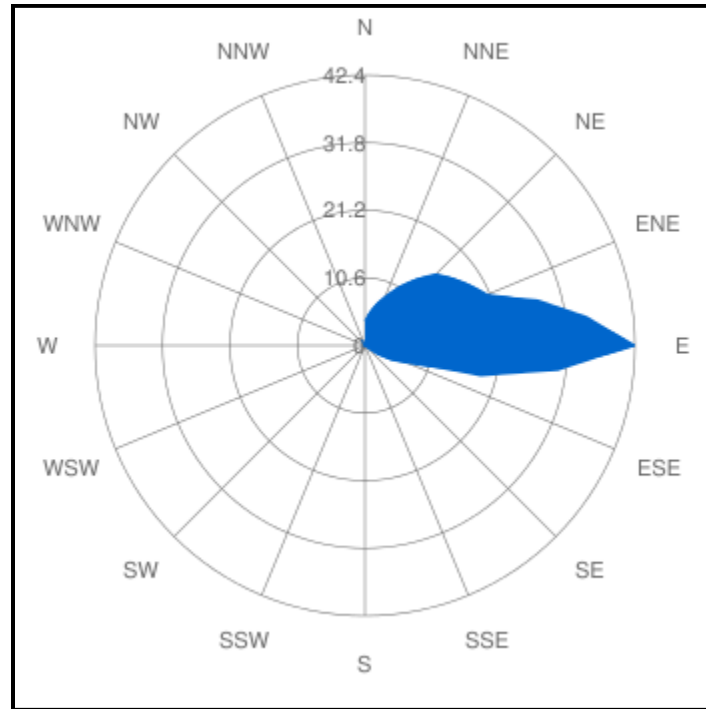
Figure 2-7. Annual Predominant Wave Direction.

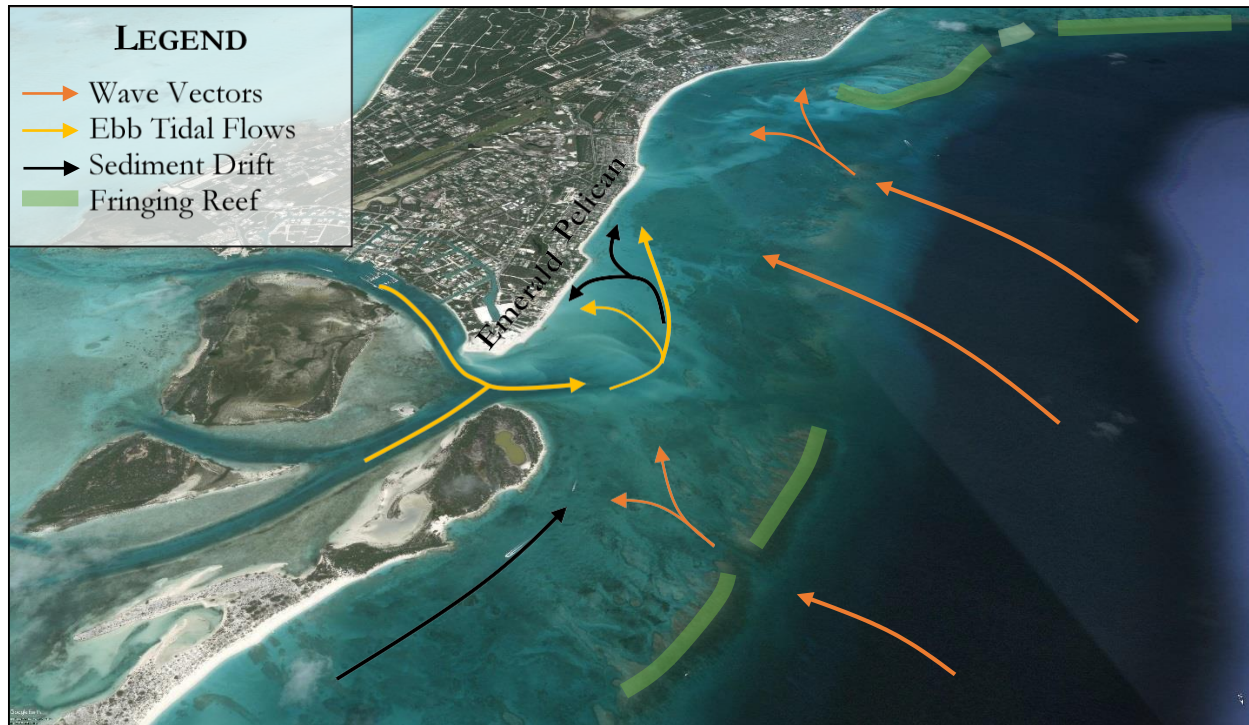
In general, the entire study area exhibits significant erosion and net volumetric loss. Areas of gain (accretion) are only associated with the updrift influence of coastal structures in the area and the relict remaining influence of previous nourishment efforts. Additional discussion regarding coastal processes including numerical modelling of the coastal system is provided in Appendix E1 and E2.

Figure 2-8. Dominant forces along the shoreline (Smith Warner 2018).

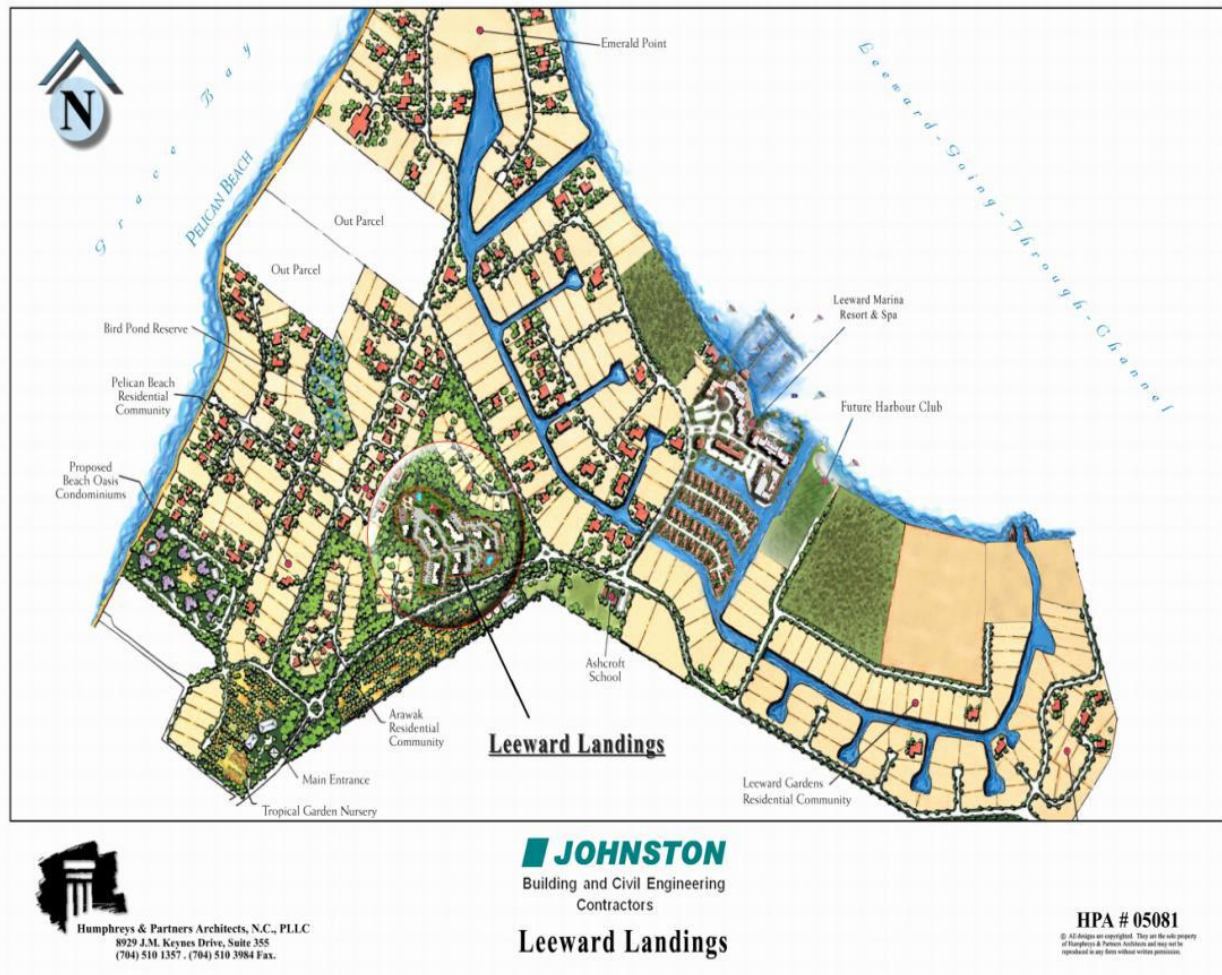
Figure 3-1. Master Land Use Zoning Plan

The Leeward Master Land Use Development Plan has the entire area zoned for mixed-use with the vast majority of the area zoned predominantly low-density residential development (Figure 3-1). The coastal areas have a mixed-use commercial development – hotels, marina and retail store units and dive shop operations.

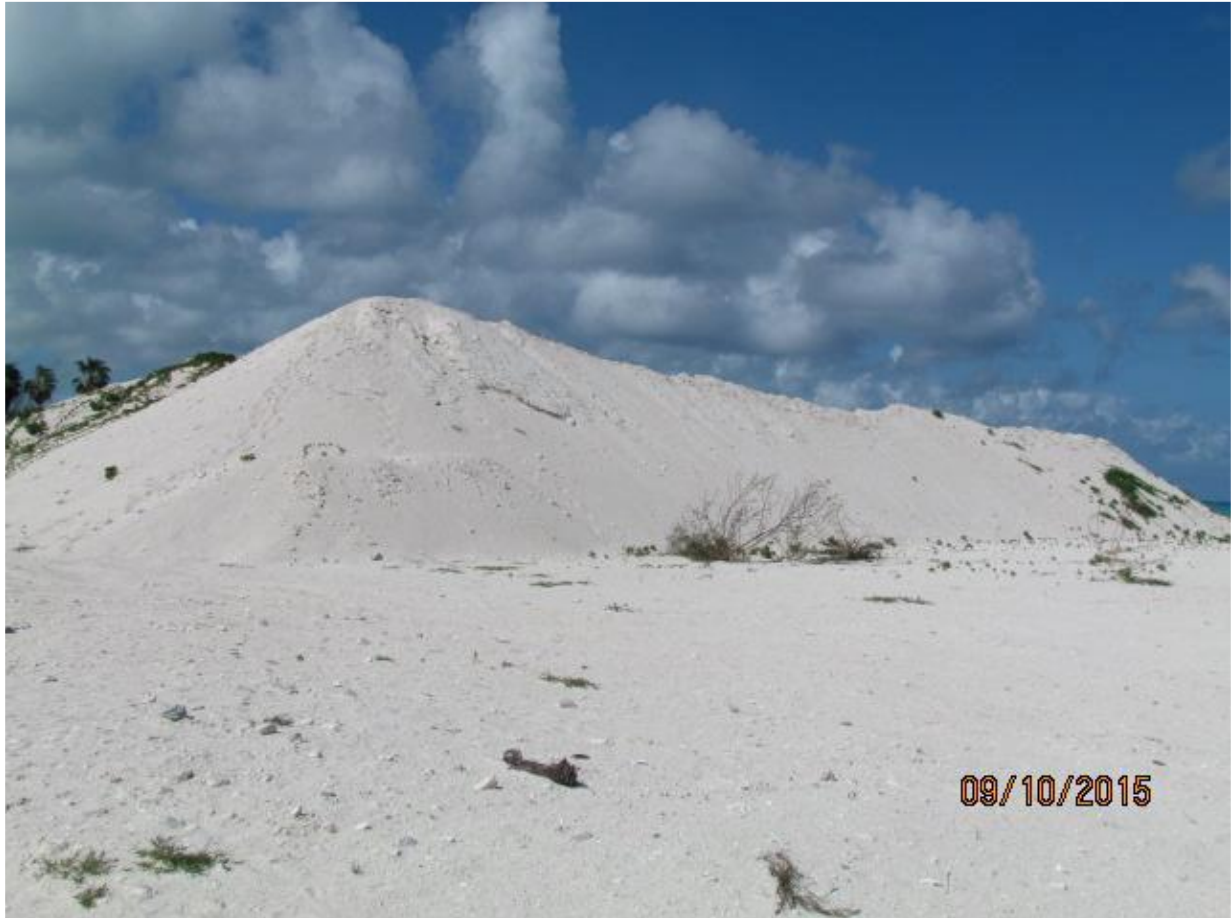
Approximately 50,000 cubic metres of sand will be dredged from the Leeward-Going-Through Channel shoal. The sediment within the borrow area is beach compatible, having an approximate mean grain size of $m0.25$ mm and contains approximately 3% silt. The colour of the sand within the borrow area is beach compatible and very closely matches the colour of the existing beach. The Leeward-Going-Through Channel has been previously dredged as part of channel maintenance. Photo 4-1 presents a stockpile of dredged material from the channel, which is representative of the material that will be dredged and placed on Emerald and Pelican Beaches.

Photo 4-1. Sand stockpile dredged from the Leeward-Going-Through Channel.
