# *Environmental Impact Assessment*

*Blue Conch Holdings IV Ltd.,  
Grace Bay, Providenciales, TCI  
PR 15580*

Blue Conch Holdings IV, Ltd.  
Turks and Caicos Islands

*June 2022*

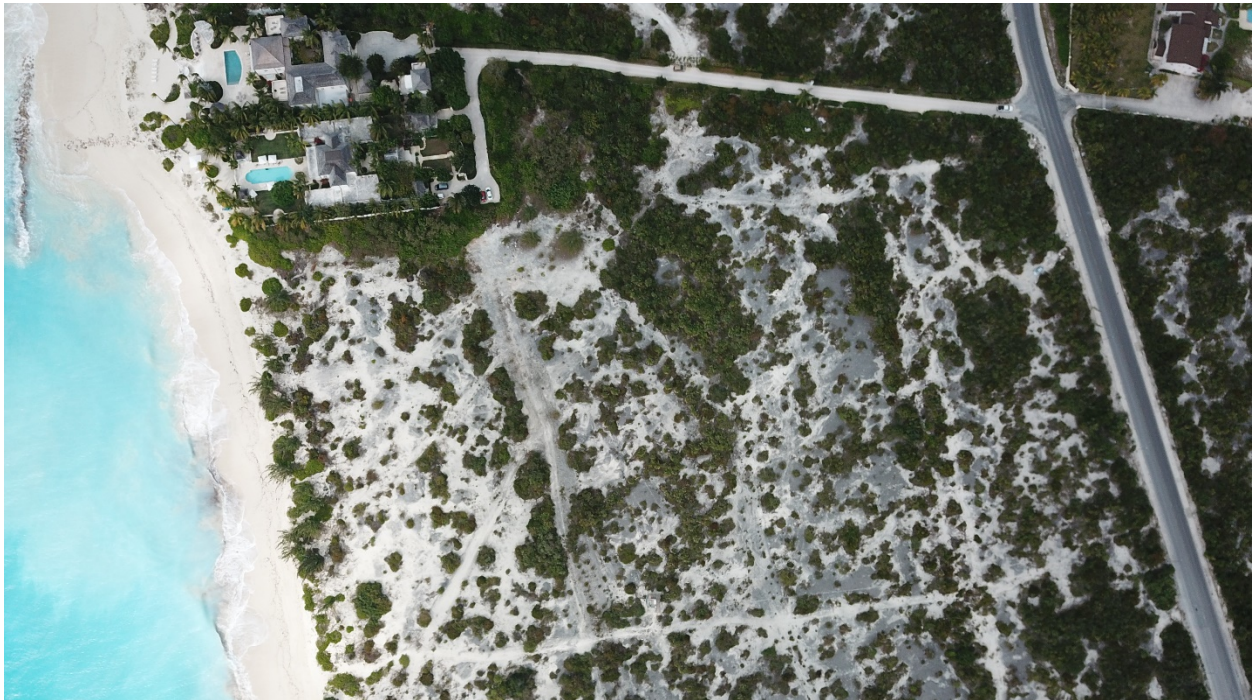
**Figure 1-1. Aerial Image of the Project Property.**

The project site is adjacent to small holiday rental homes (Coral House Villa and Coral Pavilion) at the east end of Grace Bay (Figure 1-1). Conceptual illustrations of the proposed development are provided in Figure 1-2 to Figure 1-6.

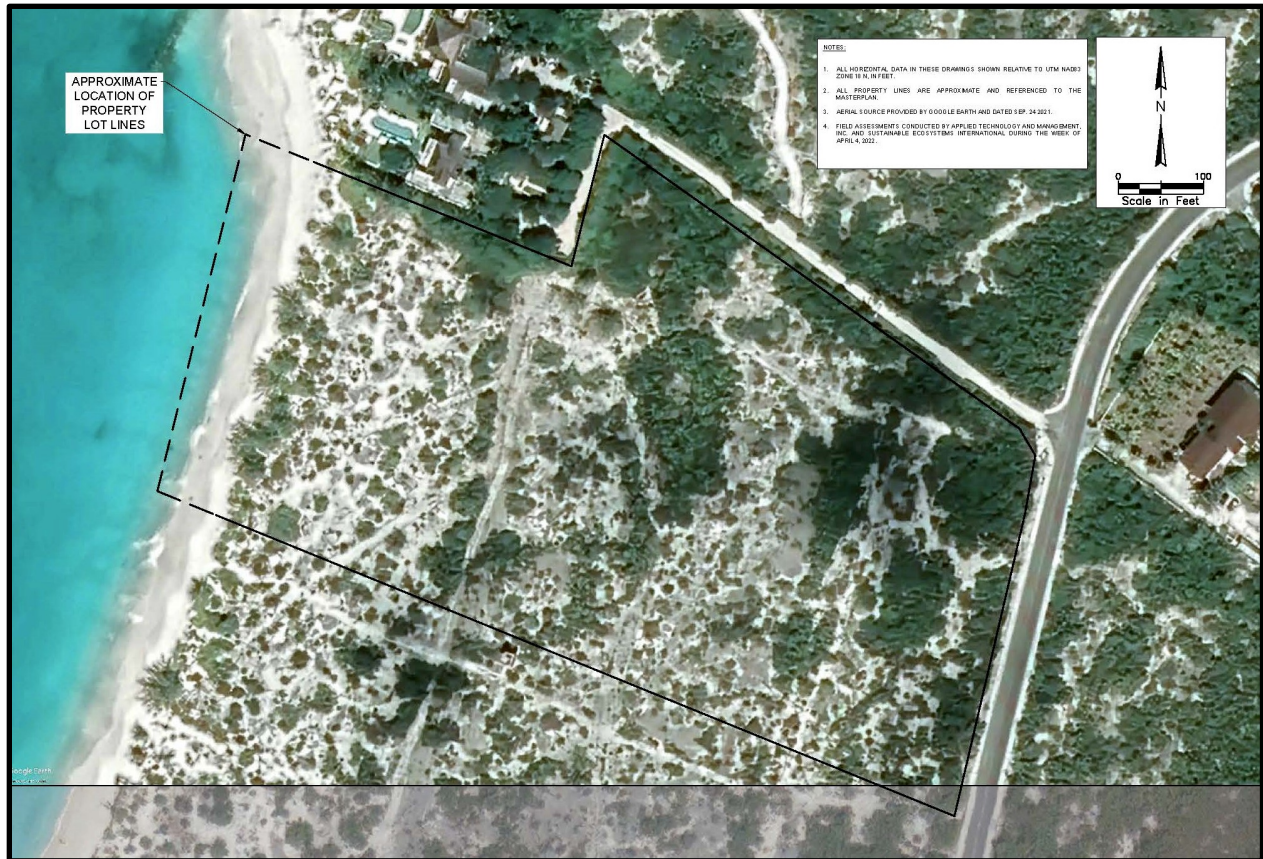
**Figure 2-1. Property Boundary**

During the week of April 4, 2022, ecological assessments of landside and nearshore marine areas were conducted on a vacant tract of land where the Resort is proposed to be constructed. The site, which is approximately 10.15 acres (4.1 ha) in size (as measured to the mean high water line) is located west of Grace Bay Road and extends northwestward to Grace Bay, on the northeast portion of Providenciales (Figure 2-1). The assessments were performed in compliance with the TOR that had been issued by the TCIG’s Planning Department prior to the proposed construction of a residential and resort project that is proposed to include four waterfront villas, three hotel buildings and townhouses. A wooden boardwalk over the primary dune is proposed for access to the beach by guests. No piers, docks or other in-water structures are proposed.

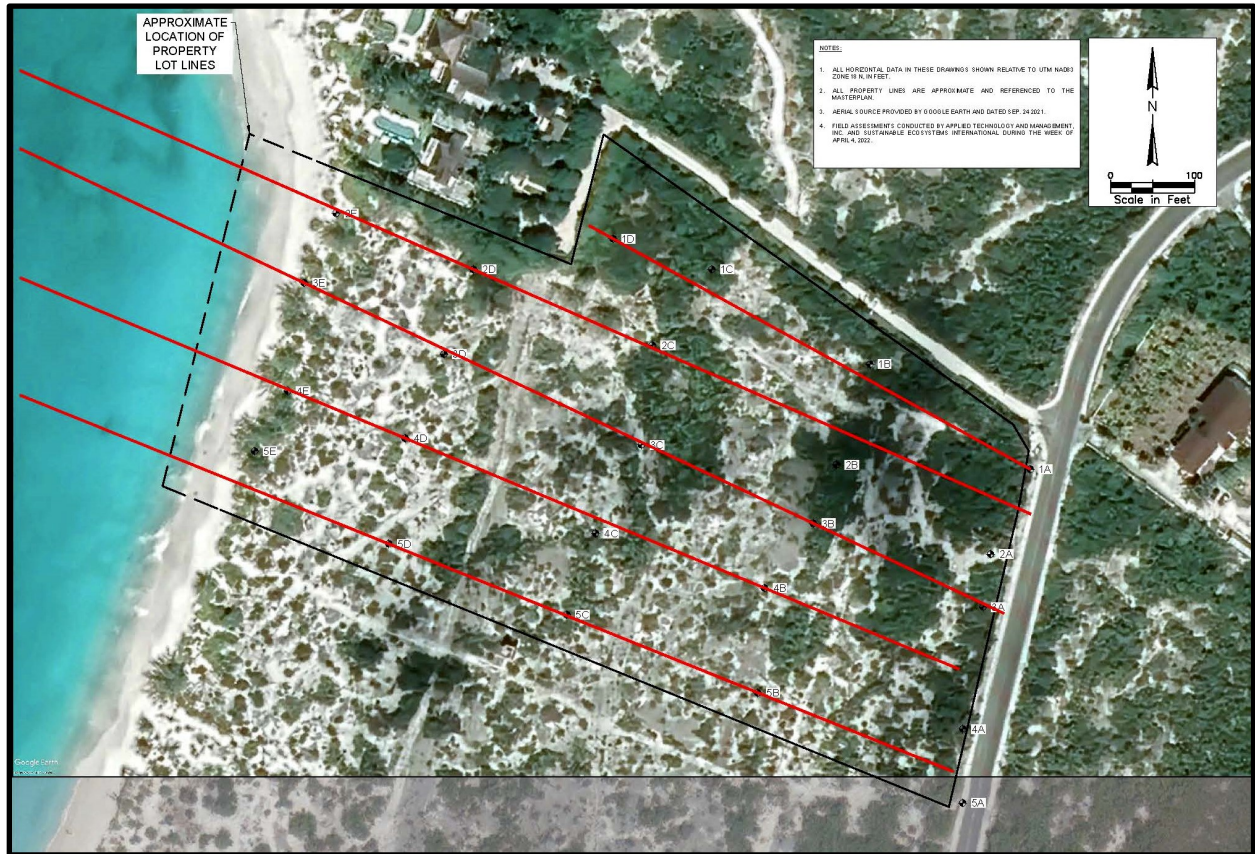
Figure 2-2. Field Assessment

The landside assessment involved direct visual observation of conditions in twenty-four 3-m x 3-m plots along five transects. It also included the recording of observations of additional species that were present on the site, but which did not occur in the plots or along the transects. Tracks of areas traversed during the assessment were recorded on a hand-held GPS system and are displayed on Figure 2-2.

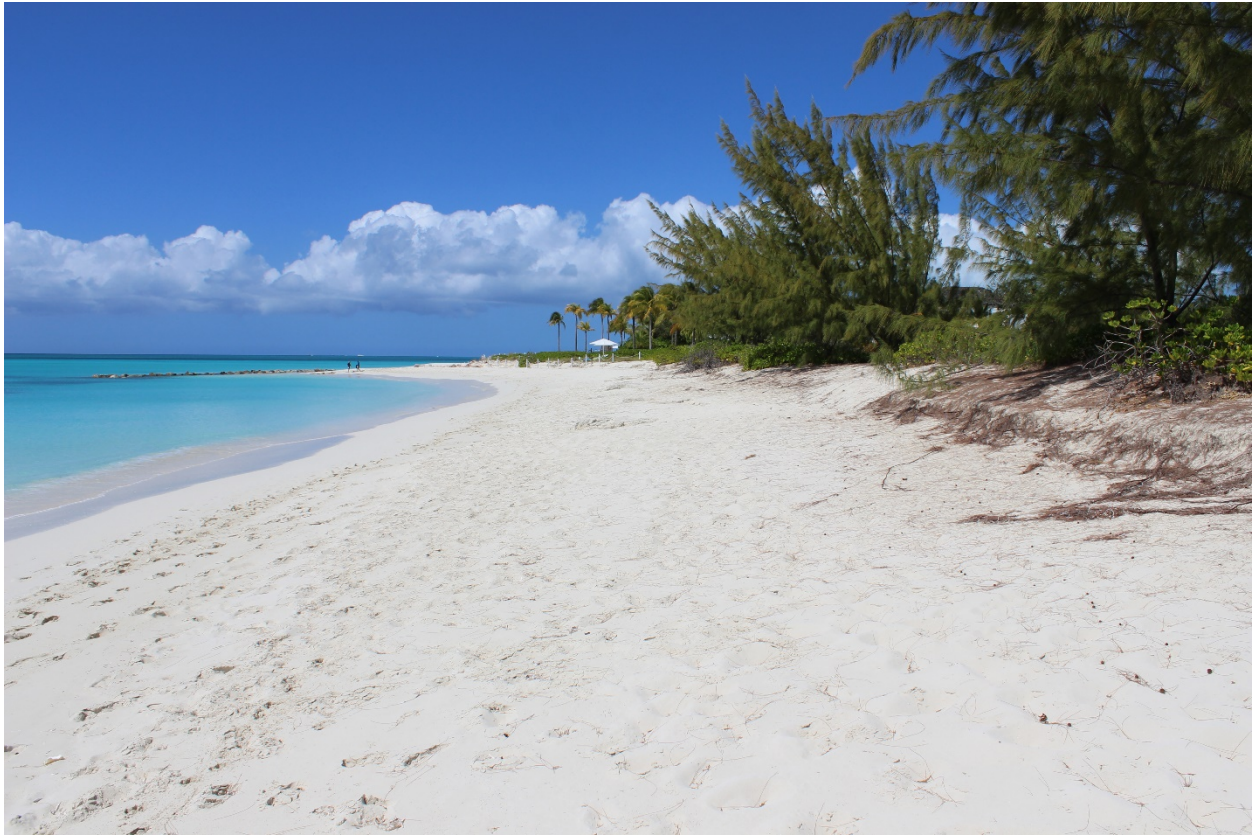
Approximately 0.48 acre (4.5% of the assessment area) was found to consist of unvegetated sandy beach located landward of the estimated mean high water line (Photo 2-1).

**Photo 2-1. Unvegetated Sandy Beach, View Looking North**  
**Date of Photo: April 6, 2022**

Openings of ghost crab (*Ocypode quadrata*) burrows or other typical beach-dwelling species were occasionally observed.

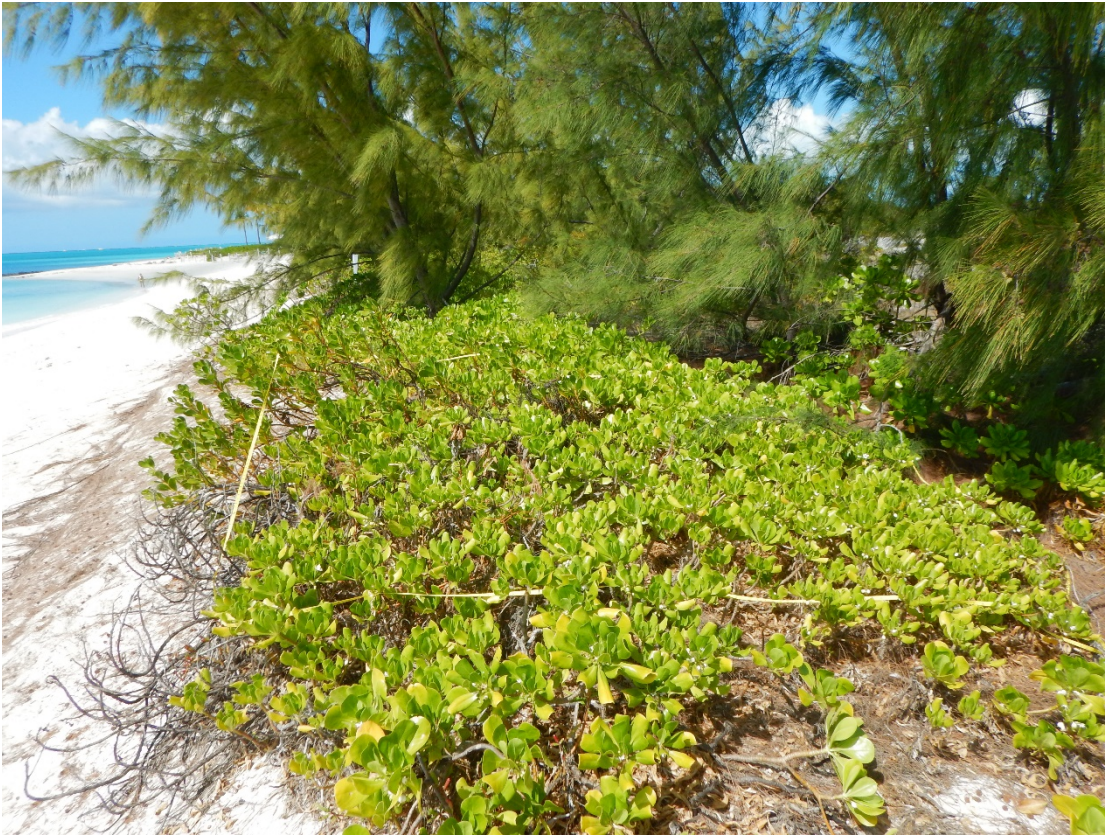
Dominant vegetation included mature Australian pine (*Casuarina equisetifolia*) trees in the canopy, and beach cabbage (*Scaevola taccada*) in the sub-canopy. In much of this area, these two pest plants constituted more than 90% of the biomass. Native salt-tolerant and drought-tolerant shrubs and groundcovers in this community included species that are able to tolerate the build-up of acid-rich *Casuarina* duff, including sea grape (*Coccoloba uvifera*), love vine (*Cassytha filiformis*), seapurslane (*Sesuvium portulacastrum*), burr-grass (*Cenchrus* sp.), bay hops (*Ambrosia hispida*) and others. Photo 2-2 is representative of conditions in this area.

**Photo 2-2. Invasive-Dominated Sand Strand, View Looking North**  
**Date of Photo: April 6, 2022**

Beach cabbage plants (Photo 2-2 from plot 5E) were present in 5 of the 24 (about 21%) of the vegetation analysis plots. They were present mostly in the invasive-dominated Sand Strand community, however in this community, they and *Casuarina* trees were the dominant vegetation. The native *Scaevola* (*S. plumieri*) was occasionally present on the property [1 of 24 (about 4%) of the vegetation monitoring plots], but it was considerably less abundant than the invasive species.

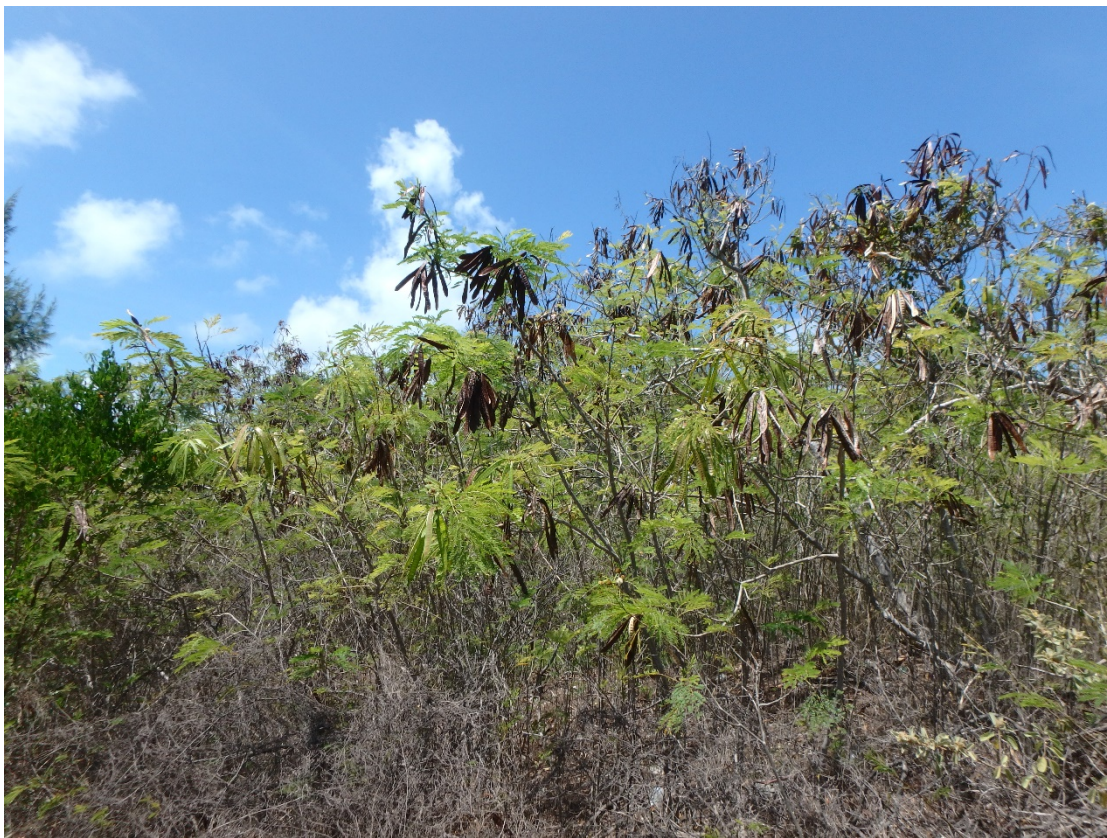
Dominant vegetation included mature cow bush (*Leucaena leucocephala*) and seaside mahoe (also known as cork tree – *Thespesia populnea*) in the canopy and beach cabbage (*Scaevola taccada*) in the sub-canopy. In much of this area, these three pest plants constituted more than 90% of the biomass (Photo 2-3).

**Photo 2-3. Invasive Dominated Uplands, View Looking North toward NW Property Boundary  
Date of Photo: April 8, 2022**

Mature cow bush trees (Photo 2-3) were present in 3 of the 24 (about 12.5%) vegetation analysis plots and were abundant in the northwestern part of the property, where they appear to have become established after that area had been cleared for the construction of the Coral House villas. They were mature, seed-producing plants.

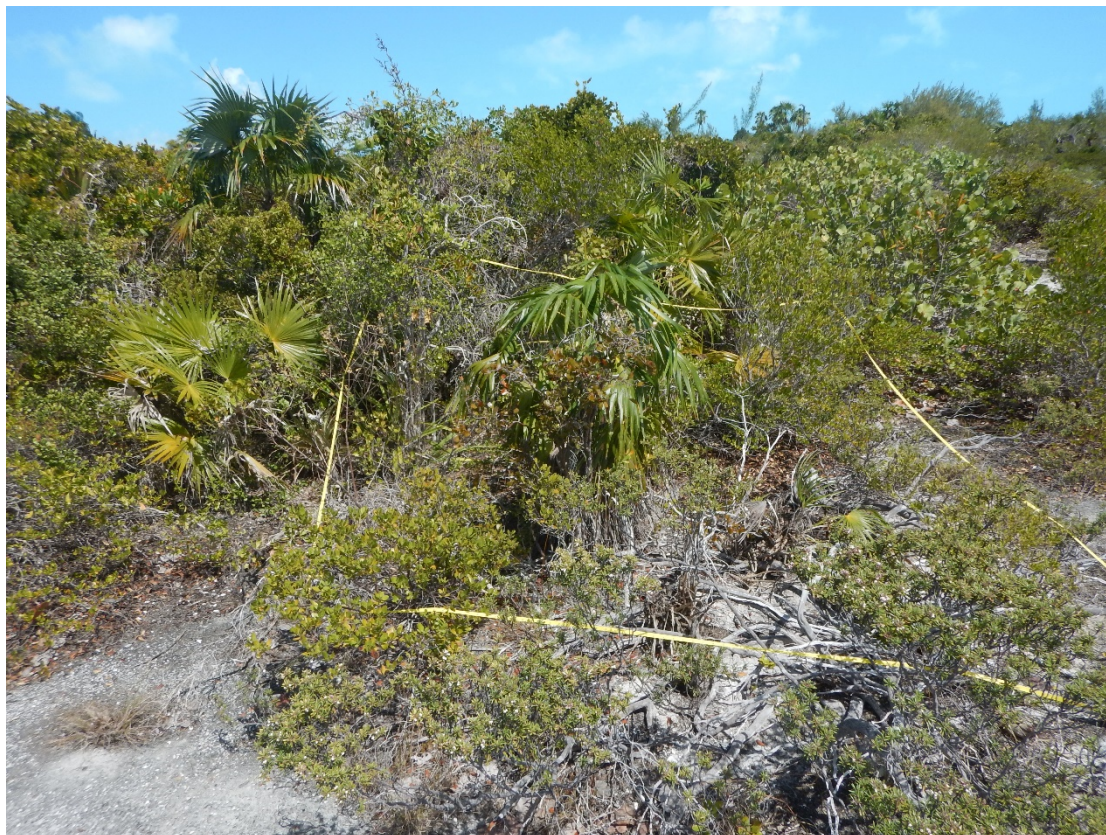
Vegetation was mostly less than 10 ft (about 3 m) in height. No wetlands were present within the assessment area. Photo 2-4 is representative of conditions in this vegetative community.

**Photo 2-4. Dry Broadleaf Evergreen Shrubland - Plot 3B, View Looking West**  
**Date of Photo: April 7, 2022**

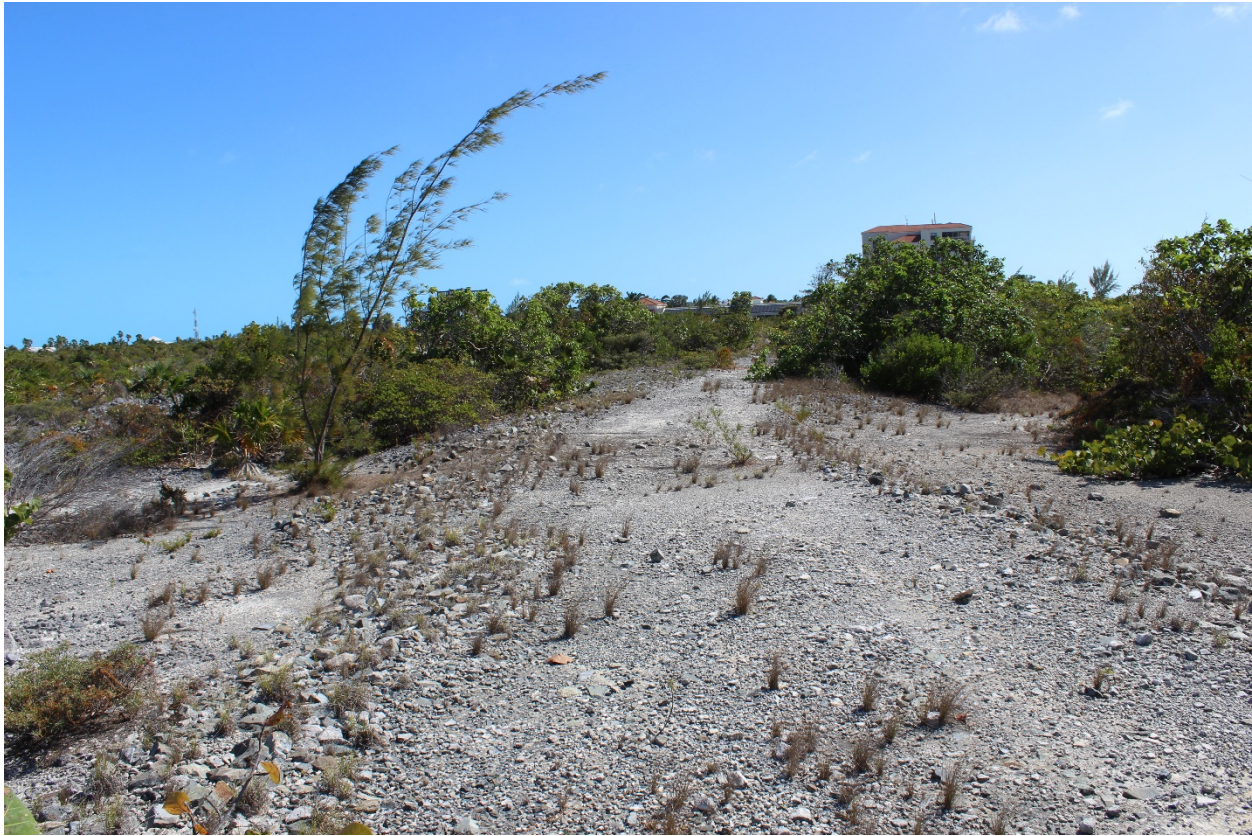
Most of this habitat was ranked as Good, in spite of a lack of diverse forest, because it appeared to be in a mostly natural state, although scars from previous land clearing activities were present, primarily in the northern portion of the property (Photo 2-7). This community did not appear to have been significantly impacted hydrologically or as a result of previous development on the site and/or on adjacent properties. It also did not exhibit any evidence of previous storm-related impacts.

**Photo 2-7. Previously Cleared Area - View Looking South**  
**Date of Photo: April 7, 2022**

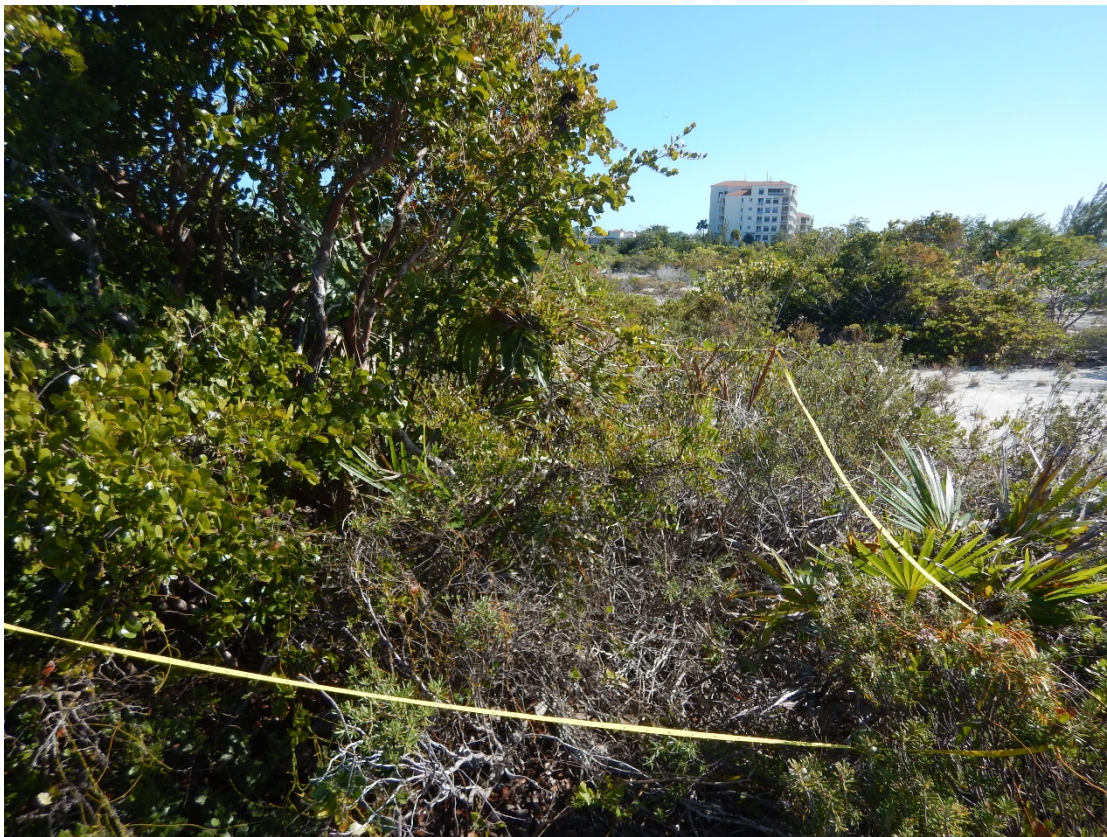
Approximately 3.62 acres of the approximately 10-acre site was found to consist of DBEF. Plant diversity was comparatively high, in some places exceeding 20 plant species in a single 3-m x 3-m vegetation analysis plot. Plant density varied considerably, from a single individual of one species to multiple trees and shrub-size individuals of other species. Photo 2-8 (Plot 3-D) is representative of the frequent transition zones between DBES and DBEF.

**Photo 2-8. Typical Transition between Dry Broadleaf Evergreen Forest (left) and Shrubland (right)**  
**Date of Photo: April 7, 2022**

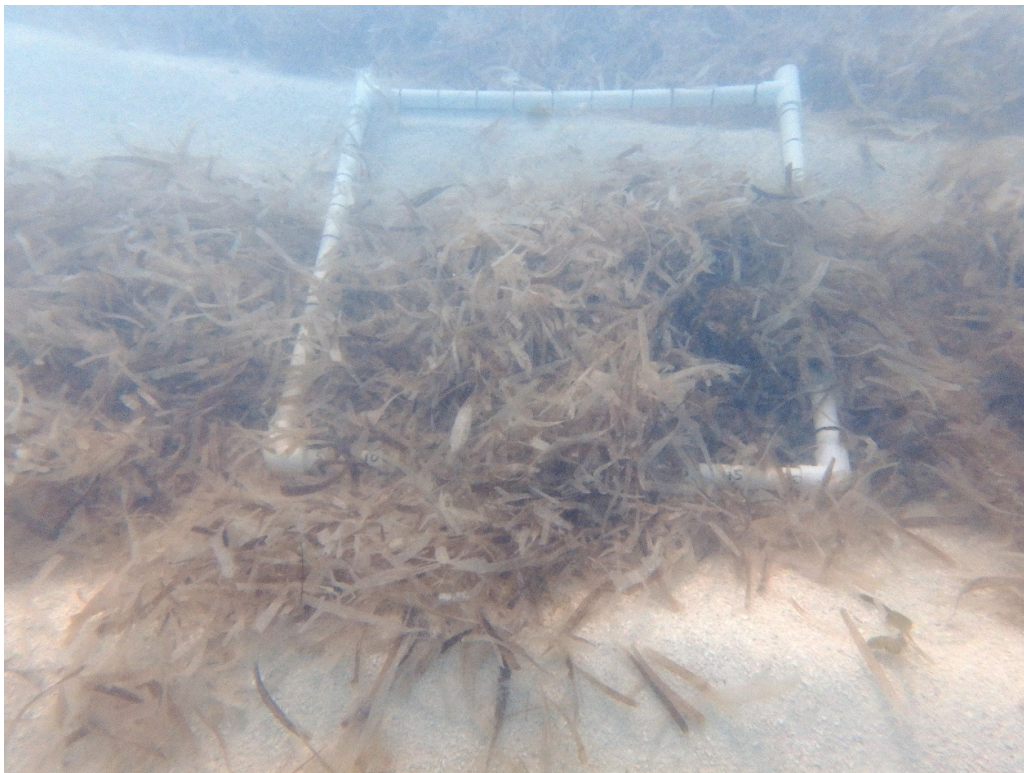
Except for a small area of *Thalassia testudinum* (turtle grass) that was present in the vicinity of the Coral Pavilion groyne, no rooted seagrasses were observed, but in different portions of the assessment area, some vegetation was present. Accumulations of dead seagrass blades and sargassum (a brown algae) were suspended in the water currents just above the bottom in a substantial portion of the assessment area. This suspension varied in thickness from non-existent or minimal in some areas, to several inches in other areas (Photo 2-20).

**Photo 2-20. Accumulation of Dead Seagrass Blades and Sargassum Suspended just above the Barren Sandy Bottom**  
Date of Photo: April 7, 2022

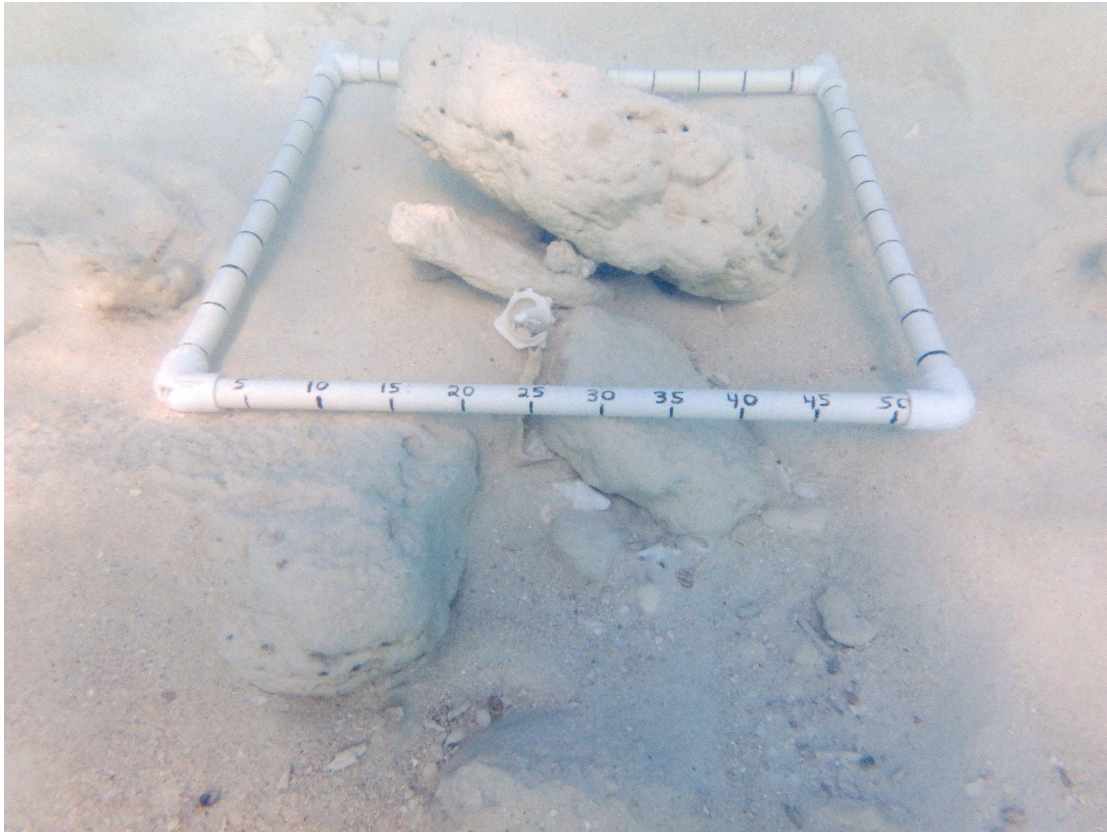
**Photo 2-22. Limestone Rocks Protruding above the Sandy Bottom in the Nearshore Waters adjacent to the Resort Property.**  
**Date of Photo: April 7, 2022**

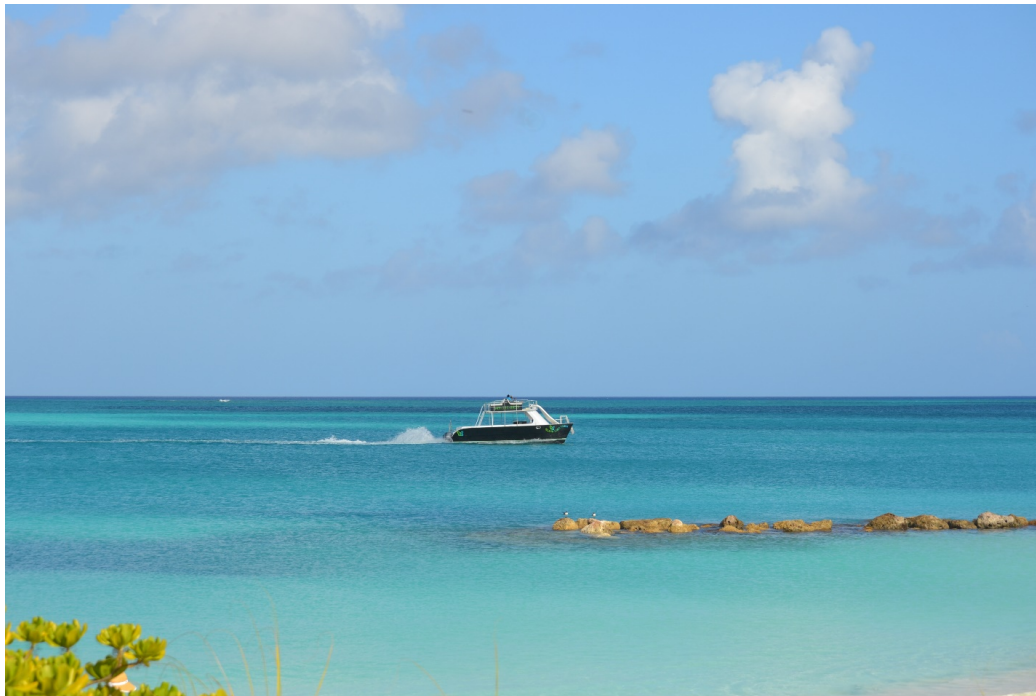
**Photo 2-23. Recreational Vessel in the Nearshore Waters adjacent to the Resort Property**  
**Date of Photo: April 7, 2022**

It was noted that recreational vessels frequently travel fairly close to shore in this area (Photo 2-23).

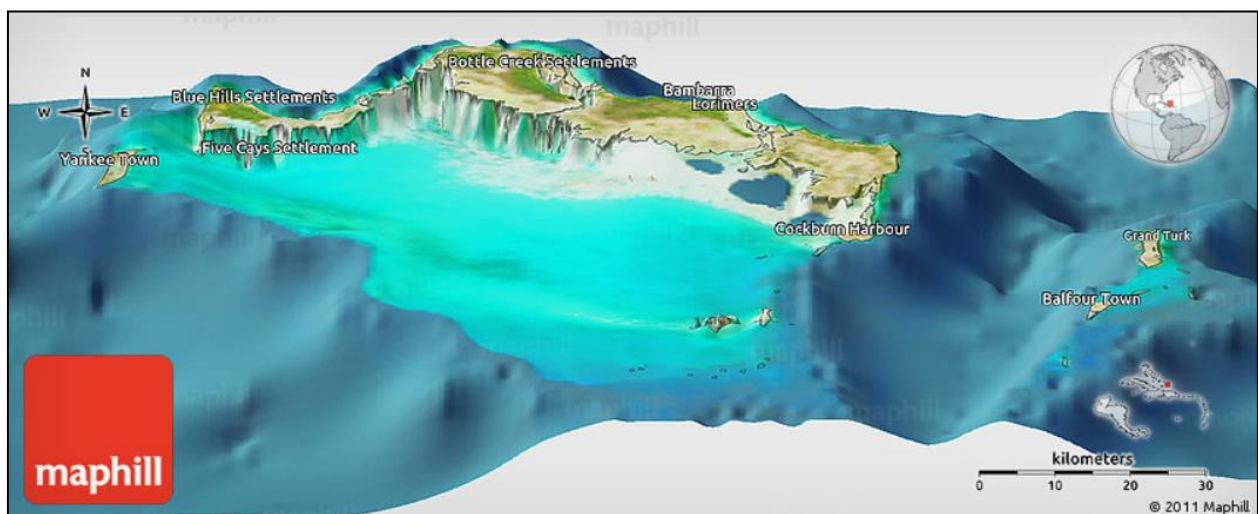
The topography of the Turks and Caicos Islands is generally very low-lying (Figure 2-5). Higher terrain for each island is normally near the outside (seaside) of each island. Areas near the Caicos Bank are lower in elevation, with many sections of North Caicos, East Caicos and Middle Caicos being low-lying swamp/marsh areas. The highest points in the country are Blue Mountain on Providenciales and Flamingo Hill on East Caicos, each with a height of approximately 48 m.

**Figure 2-5. General Topography and Bathymetry of Turks and Caicos**

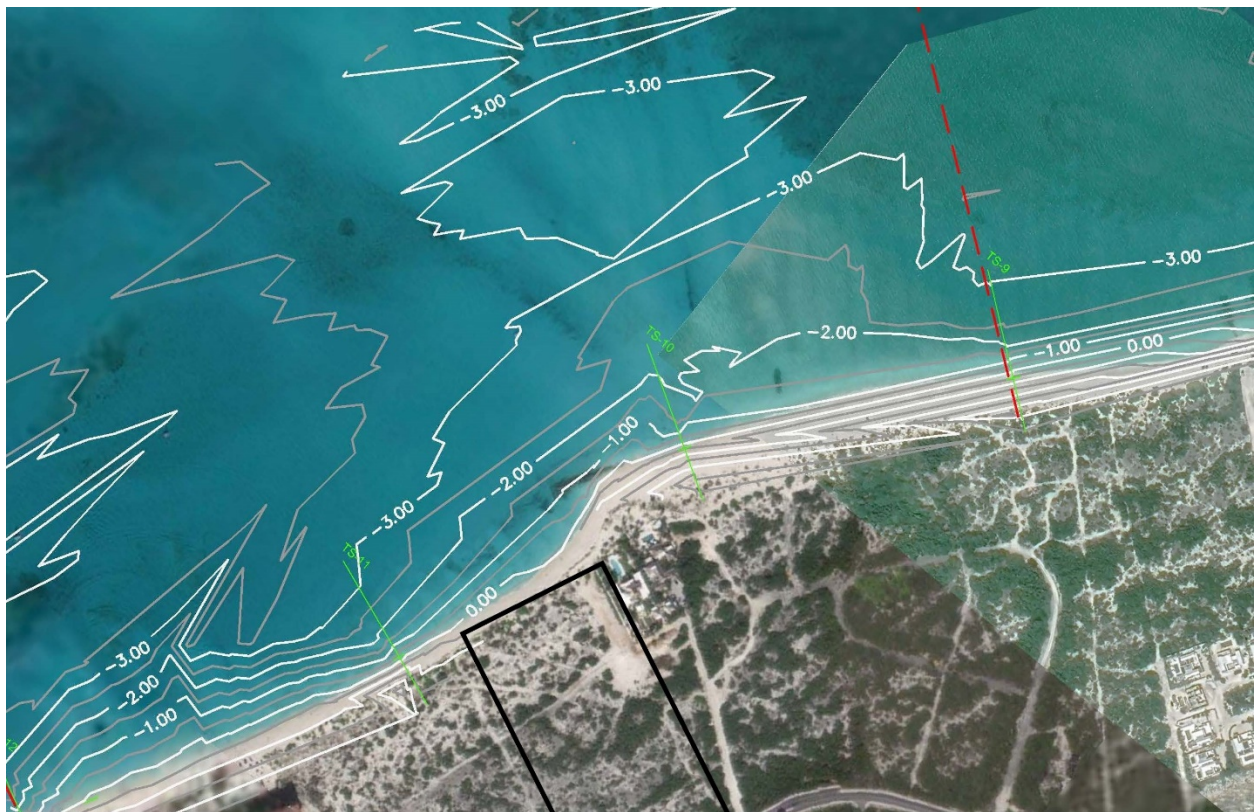
**Figure 2-6. Survey Contours**

Survey data from September-October 2021 were collected adjacent to the proposed resort property, and the contours from that data are presented in Figure 2-6.

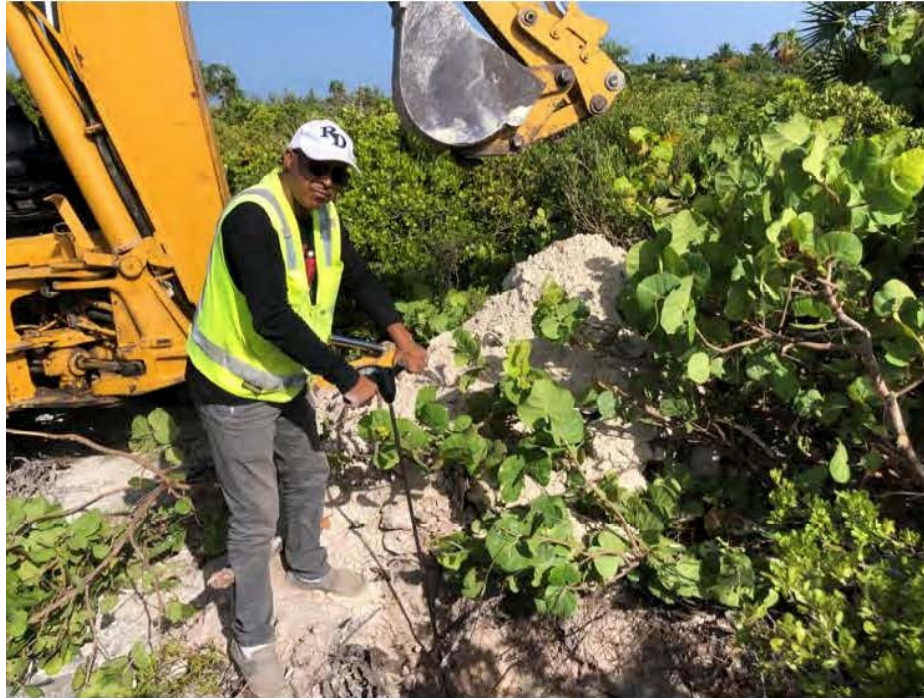
penetration resistance of soils in shallow exploration work. Geotechnical laboratory testing of soil samples were performed per ASTM standard methods. In the execution of the geotechnical studies the field investigation and geotechnical trial pit logs provided factual geotechnical characterization of the shallow bearing soils, which was interpreted for geotechnical analysis of static and seismic conditions. The analysis included assessment of the performance of total and differential settlement analysis, allowable bearing calculations, and seismic site classification.

**Photo 2-24. Trail 60-degree cone tip resistance at- 2ft is 12kg/cm<sup>2</sup>. Oolitic white sandstone uniformly underlines  
(Tolleson, 2019)**

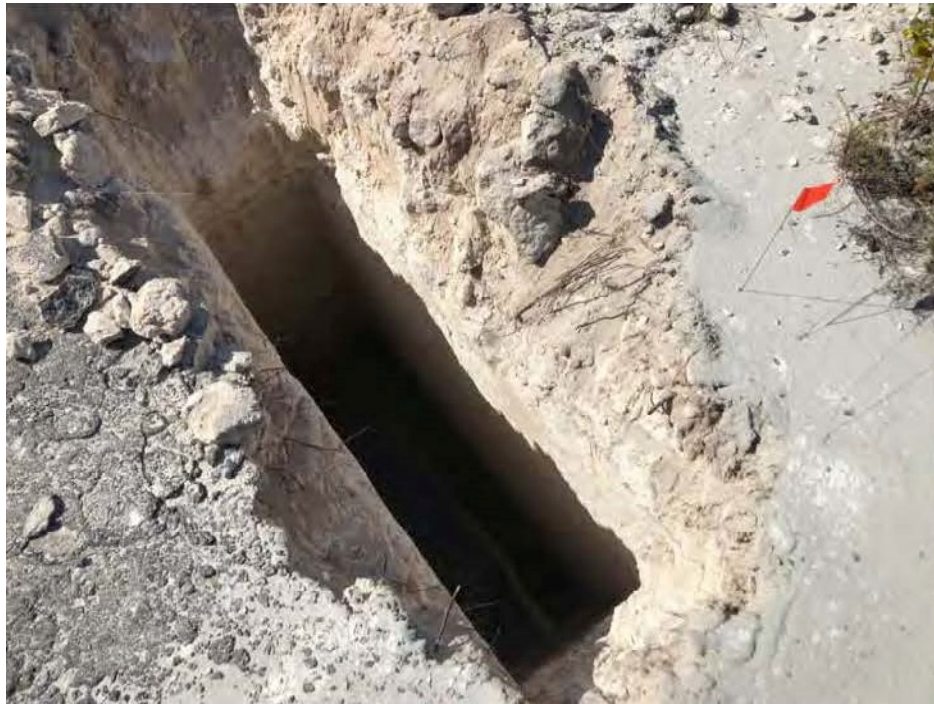
carbonate platform that rises from the seafloor and is exposed above sea level as it exists now. The surficial soil exposure on the project site is composed of partially to fully cemented Oolitic sandstone. Locally, the exposed white to tan colored sandstone is referred to as caliche sandstone. The sandstone is friable, and the mechanical properties can be correlated to mean particle diameter. (D10, D50 and D90) taken from the ASTM- D422 grain size testing. The average D10 value from all bulk samples is a very fine sand with diameter on order of  $\sim 0.075\text{mm}$ . The D50 value is a fine sand with an average diameter of  $0.18\text{mm}$ . The D90 value is a medium sand with a diameter of  $1.8\text{mm}$  (after redacting cobble size fragments).

**Photo 2-25. Trial pit excavation. Note Clean open pit. Excellent bearing capacity. (Tolleson, 2019)**

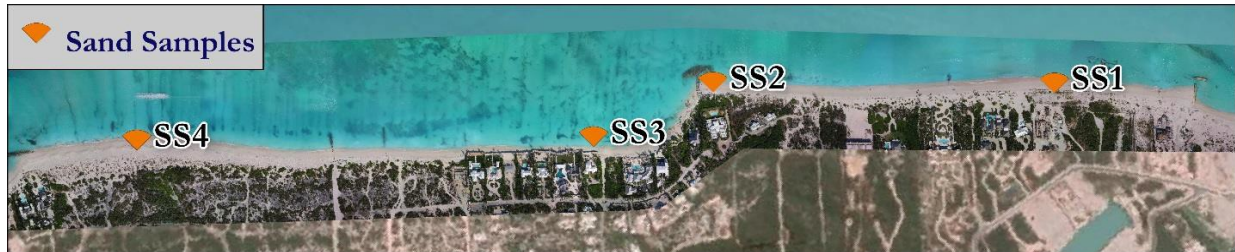
Figure 2-7. Sand Sample Locations

inspected, air dried and subjected to a standard dry sieve analysis to determine their grain size distribution as well as other characteristic parameters. The results are summarized in Table 2-5.

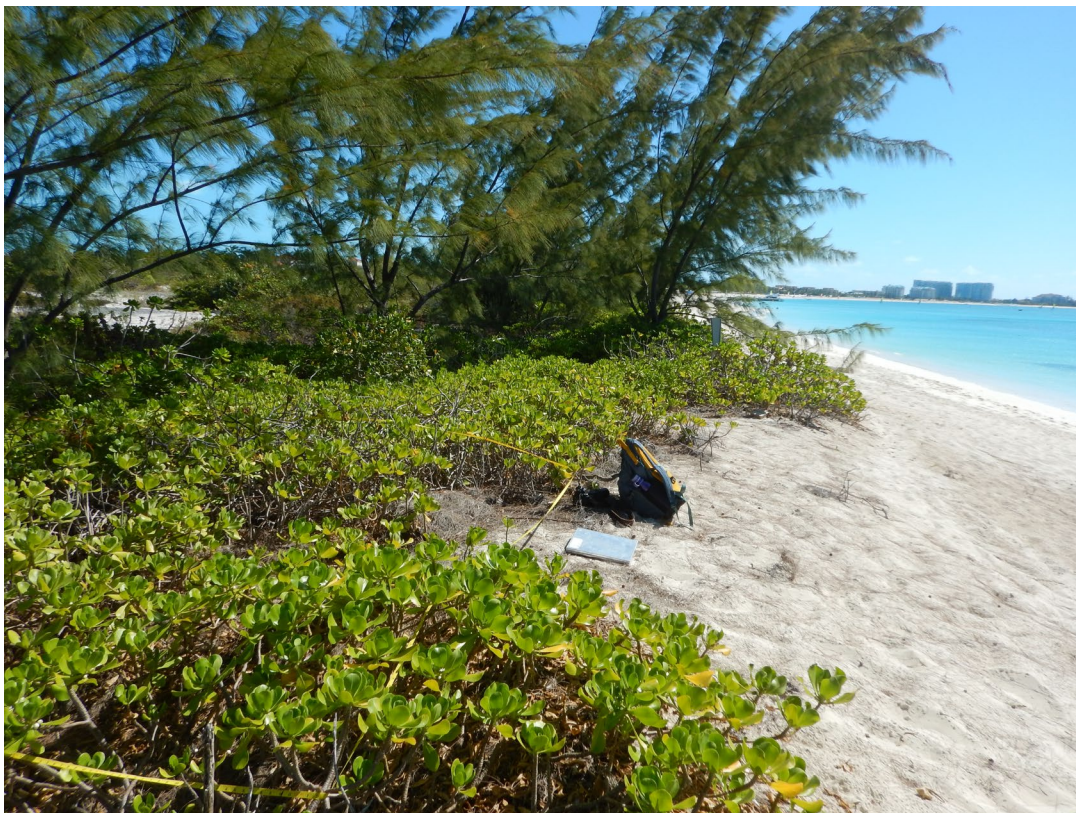
Photo 2-26. *Casuarina equisetifolia* and *Scaevola taccada* in the Dune

The aesthetics of the shoreline will remain natural. The client intends to remove the non-native invasive shoreline species and replace them with non-invasive and endemic dune plantings common to the Turks and Caicos Islands.

A formal landscaping plan is included in this project, the Developer should be encouraged to plant beach stabilizing native species in the upper part of the beach and remove invasive exotic species (**Error! Reference source not found.**).

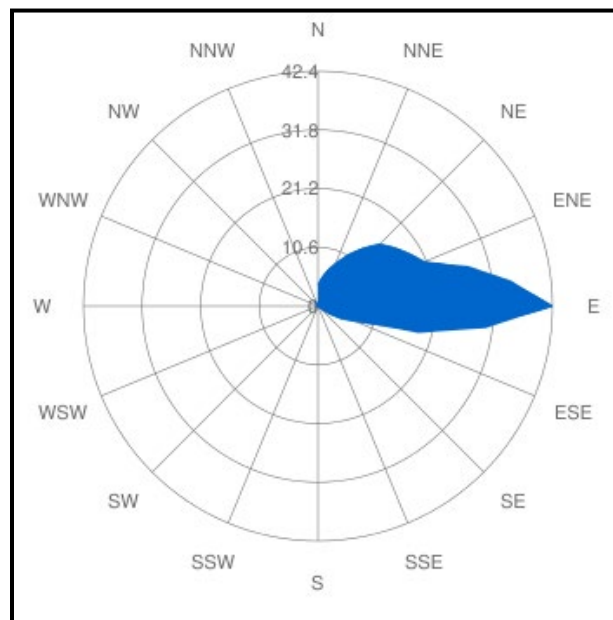
The construction of the groyne in the vicinity of Coral House (to the west of this project) and renourishment associated with its construction has resulted in the establishment of a relatively stable beach profile to the west and within the project area. Further, it does not appear that long term, the groyne structure has resulted in an appreciable downdrift impact or interruption of the natural supply of sand to beaches to the west. In general, the sediment transport of material along the shore is from east to west, as is observed in the accretion of sand along the eastern side of sand structures along the coast (Figure 2-8).

**Figure 2-8. Annual Predominant Wave Direction.**  
Source: <https://wisuki.com/statistics/936/long-bay>

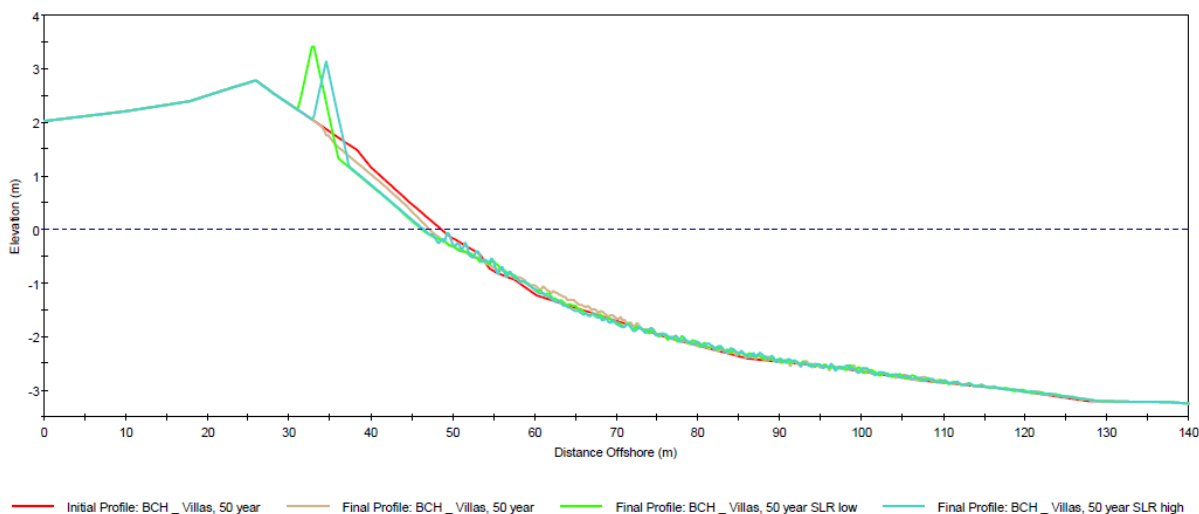
An additional site concern relative to sea level rise is the low elevation of interior portions of the property that, at present, are on the order of +2 ft relative to mean sea level. As overall raising of the property grade, particularly within these areas, is proposed, site development incorporates appropriate strategies for adaption to increases in sea level rise .

**Figure 6-1. SBEACH Modelling of Shoreline Response for a 50-Year Storm Event for a Range of SLR Projections**
