EnvironmentALL is pleased to submit an Environmental Impact Assessment relating to the Grant of Outline Development Permission for the Beaches Resort-Treasure Beach Expansion Project (PR15741).

# **ENVIRONMENTAL IMPACT ASSESSMENT**

BEACHES RESORT: TREASURE BEACH EXPANSION PR15741

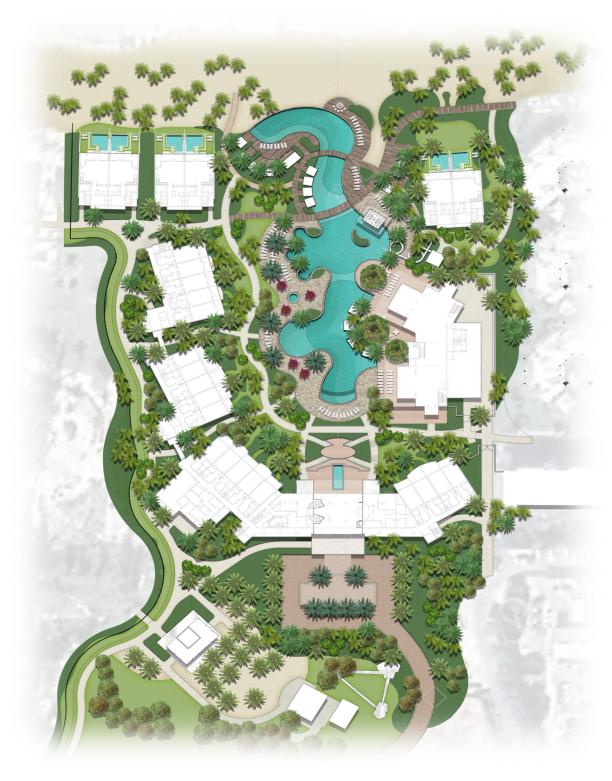
Figure 2. Master Plan-Beaches Treasure beach Expansion Project

- a. multi-level (5 floors) guest room structures
- b. split-level beach front family villas
- c. split-level structure housing several restaurants
- d. a stand-alone cultural jerk pit
- e. kids' playground, assorted inground pools/cabanas

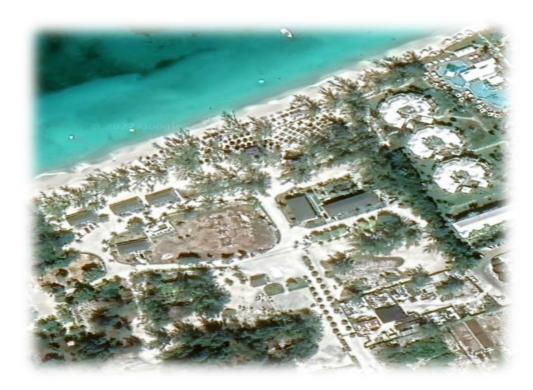
Figure 3. Pre-existing built structures

A comparison of a google earth photo (pre-2022) and drone photos taken on 25<sup>th</sup> February 2022 and 14<sup>th</sup> April 2022 illustrates a time lapse of the extent of land clearing that has taken place and renders the site entirely anthropogenic. Figure 3 depicts the built environment that was pre-existing within the project site including residential homes. Figures 3a and 3b illustrate varying degrees of impacts to the site including land clearing and building demolition.

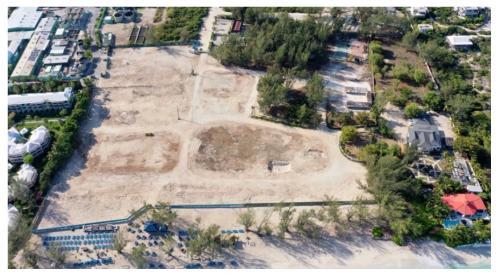
Figure 4. Cleared vegetation across project site

Terrestrial assessments were conducted during the week ending 8<sup>th</sup> April 2022. Project works up to the time of field investigations on 6<sup>th</sup> - 7<sup>th</sup> April 2022 included demolition of buildings and complete clearing of the site except for a stand of the invasive alien species *Casuarina equisetifolia* (Australian Pine) present along the shoreline and a small patch of *Coccothrinax inaguensis* a Lucayan endemic species, Figure 4.

The removal of vegetation has left the project area completely cleared to 'barren Earth' and highly susceptible to dust pollution, in the immediate and surrounding areas, during windy conditions.

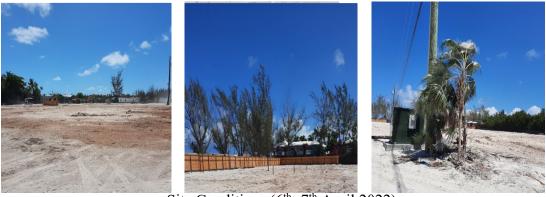
Site Conditions (6<sup>th</sup> -7<sup>th</sup> April 2022)

The beach profile along the Northern boundary of the site has a slope between 10% and 15% (based on visual observation), with approximately 20-25 feet of dry beach beyond mean high tide, and a low foredune that is devoid of native dune vegetation. *Casuarina equisetifolia* is present in a row along the dune crest, Figures 5. There are less than twent-(20) individual plants approximately 25 feet in height.

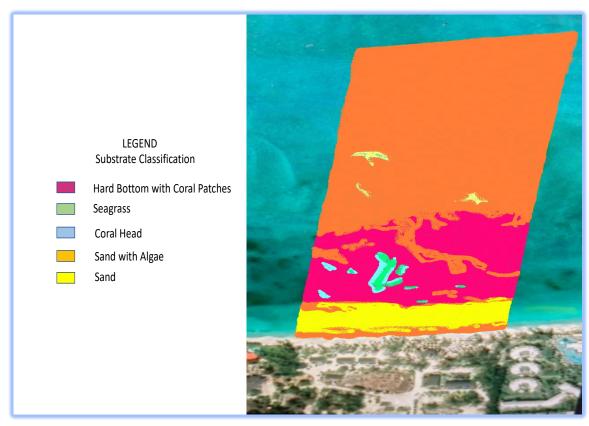
Figure 7. Benthic Map

Baseline marine assessments were conducted on 7<sup>th</sup> April 2022. The marine environment is not subject to any direct impacts from the proposed development and no development will occur in the marine environment. Indirect impacts are expected from wind-blown debris during the construction phase. A benthic description of the immediate and surrounding marine environment was undertaken. In general, the benthic composition varied from sandy shore to sandy bottom with areas of seagrass beds interspersed with algae and hardbottom and patch reefs Figure 7.

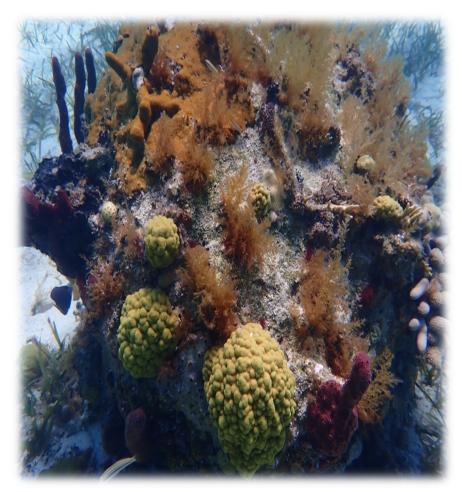
Figure 9. Isolated Patch Reef Structure

The benthic hardbottom were noted as areas with <5cm of sand and areas of exposed rock. The hardbottom and coral dominated areas accounted for approximately 39.19% benthic cover of the area. Hard corals were assembled in small and medium patches or individual heads. The corals in the area were in relatively good health and there were no physical signs of stony coral tissue loss disease in the area. The most abundant coral present was the Mustard Hill Coral, *Porities astreoides*. Other reef building corals were observed in low diversity and abundance. Patch reefs were observed on the fringes of the hardbottom coral reef systems to the east and scattered through the western portion of the area of study. Patch reefs are stony coral dominated high relief structures that are some of the most diverse and productive habitats. The patch reefs occurred as isolated structures Figure 9. They are built on the remains of dead coral skeletons that accumulated over time. During the assessment boating, swimming and snorkeling were observed in the area.

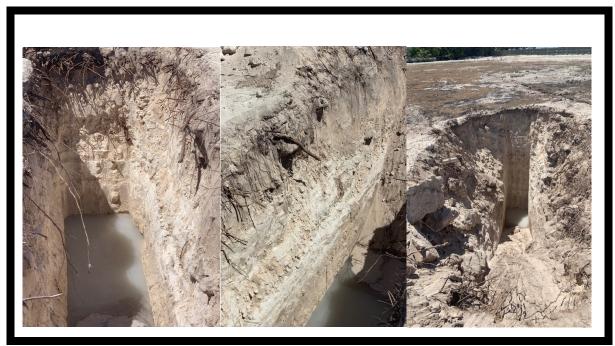
Figure 10. Photo of earth layers

revealed a relative thin layer of loosely compacted Holocene sand that transition to well

compacted and well cemented Limestone formation. Paleo soil zones were not observed

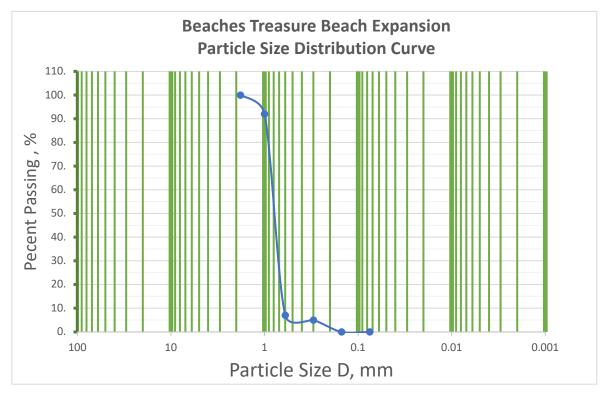
Figure 11. Grain Size Distribution Curve

Using the sample data, a particle size distribution curve, Figure 11, was created as illustrated in the figure below. The D60, D30 and D10 values were 0.84941176, 0.70823529 and 0.61411765, respectively. The coefficient of uniformity ( $C_u$ ) was 1.38314176 and the coefficient of curvature( $C_c$ ) was 0.36365063. The results from the sieve analysis indicated that the sand sample was uniformly graded, fine grained sand.

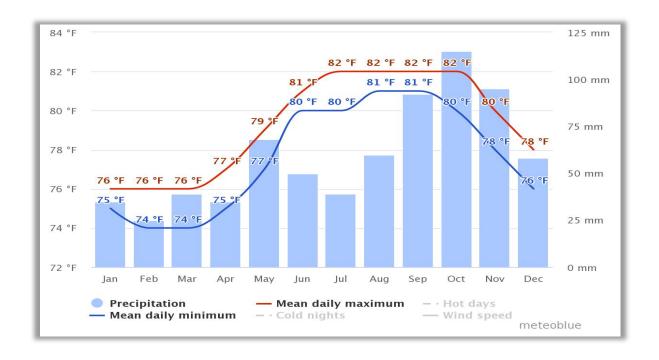
Figure 12. Historical Climate data(2009-2021 (Source MetaBlue)

Historical meteorological data from the southeast Bahamas and Grand Turk (Bahamas Meteorological Department – Bahamas Government) suggests an average annual rainfall of approximately 28 inches with the greatest amount of rainfall occurring during the months of May and October each year. Temperatures average 29°C (85°F) in summer and 21°C (70°F) in winter. Maximum and minimum temperatures seldom exceed 32°C (90°F) or 16°C (60°F). Historical model data (source:Meteoblue) from 2009 to 2021 is illustrated below in Figure 12.

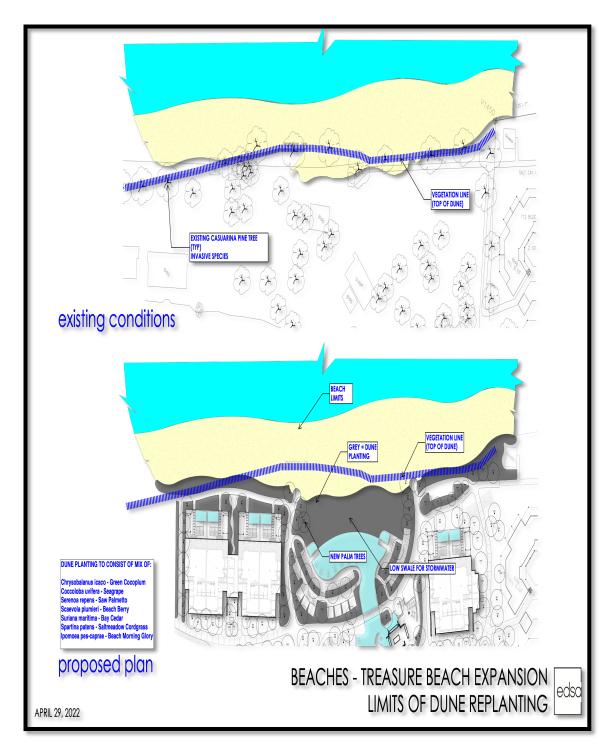
Figure 14. Landscape Plan (Source: EDSA)

A land scape plan , Figure 8, will introduce non-invasive native species that will be used extensively where possible.

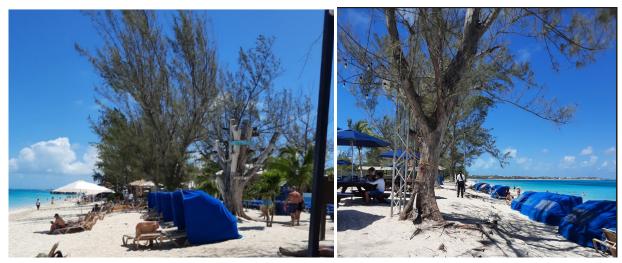
Figure 2: Shoreline with Australian Pine (Left - view facing East, Right - view facing West)

The beach profile at Northern boundary of the site the site has slope that is visually ranges between 10% and 15% with approximately 20-25 feet of beach slope (dry beach beyond mean high tide) and a low foredune that is devoid of native dune vegetation. *Casuarina equisetifolia* is present in a row along the dune crest. There are less than twenty individual plants approximately 25 feet in height with an average dbh (diameter at breast height) of x.

Removal of the invasive Australian Pine and landscaping with native species are proposed as a mitigation for project impacts. While these activities will have positive impacts there are also possible negative impacts associated with implementation of these actions to manage. This Invasive Species Removal and Control Plan was developed to guide the removal and replanting activities for the project.

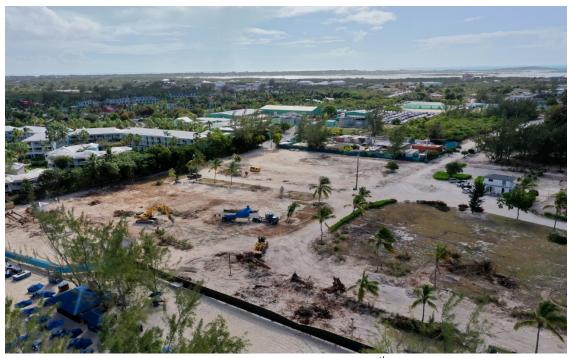
Treasure Beach Site Clearing: Drone photo 25<sup>th</sup> February 2022

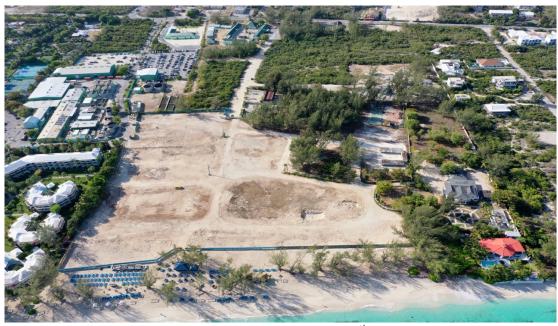
Treasure Beach Site: Drone photo 14<sup>th</sup> April 2022
