DRAFT COMPREHENSIVE ENVIRONMENTAL IMPACT ASSESSMENT (CEIA)

**REPORT - BLUE WATER LAGOON BASIN, PENINSULA INLAND CANAL,
ENTRANCE CHANNELS, AND BOAT DOCKS PROJECT**

SAIL ROCK PENINSULA

SOUTH CAICOS, TURKS AND CAICOS ISLANDS

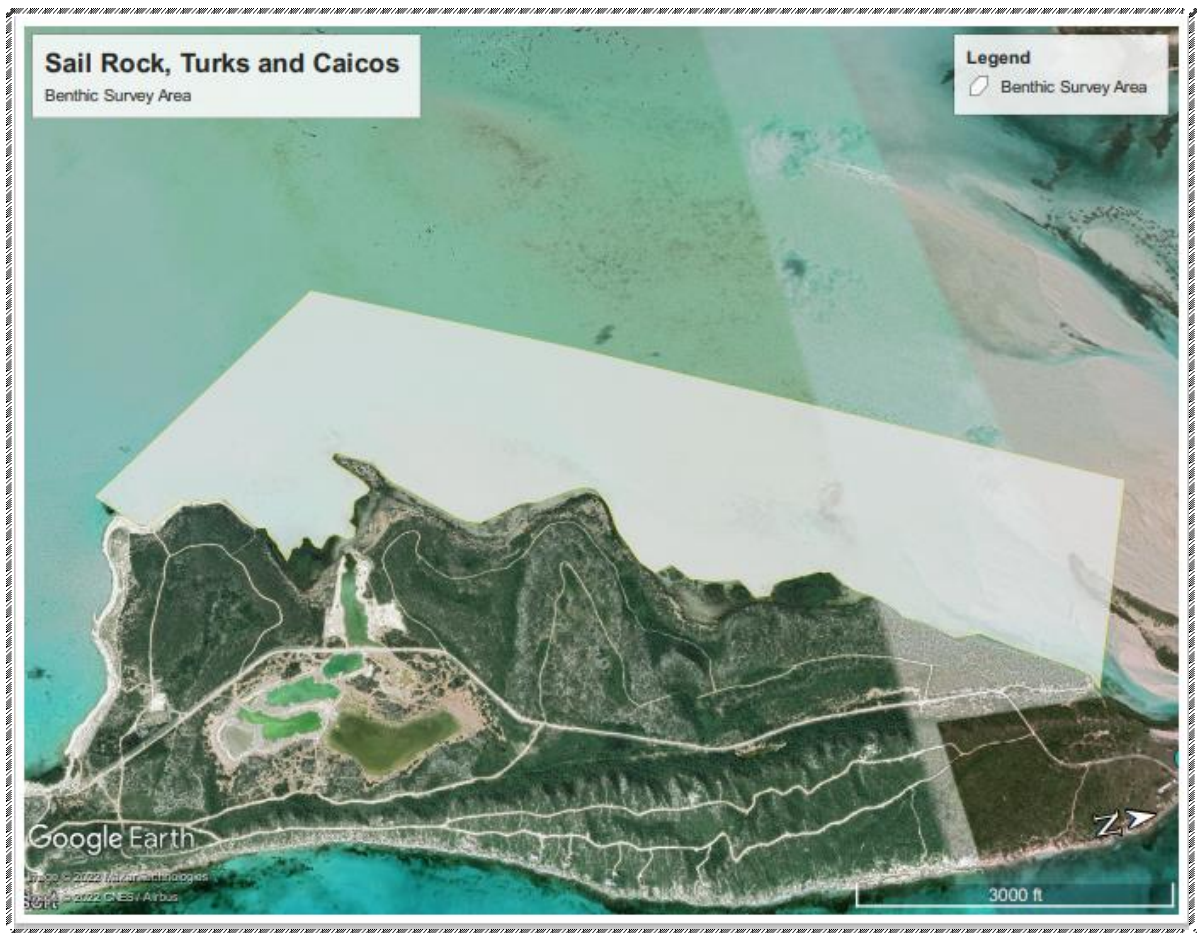
Figure 9: Benthic Assessment Survey Area

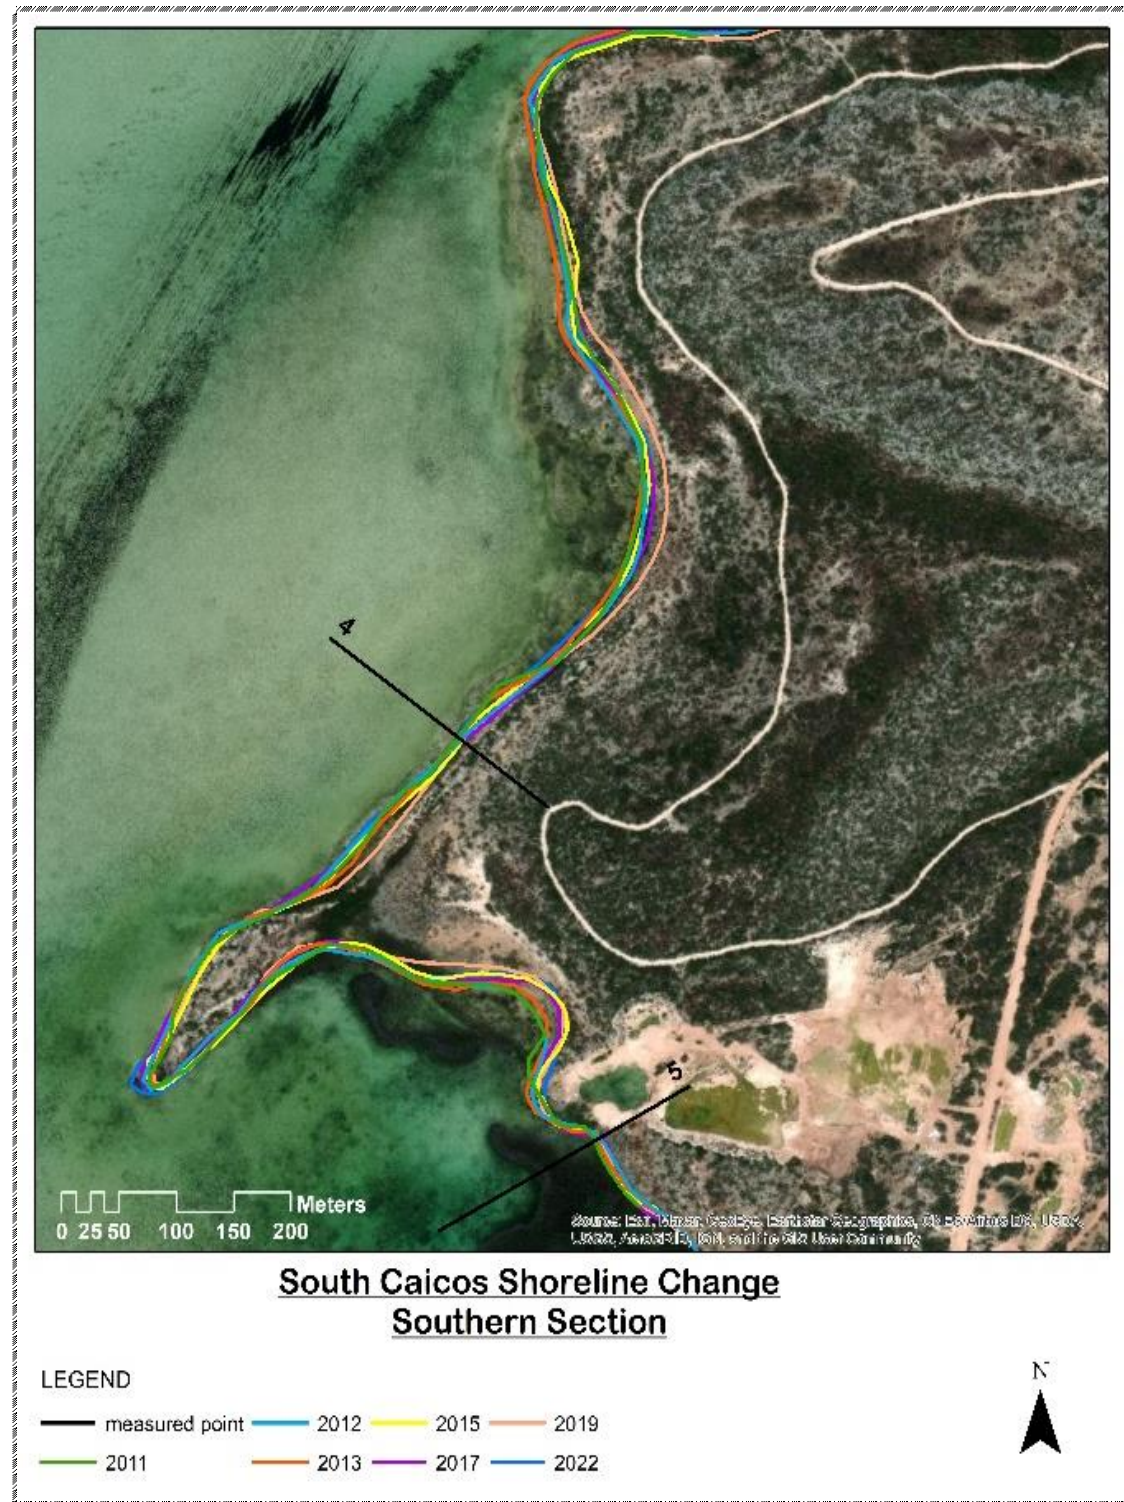
Figure 20: Historical shoreline positions close to the Southern channel entrance

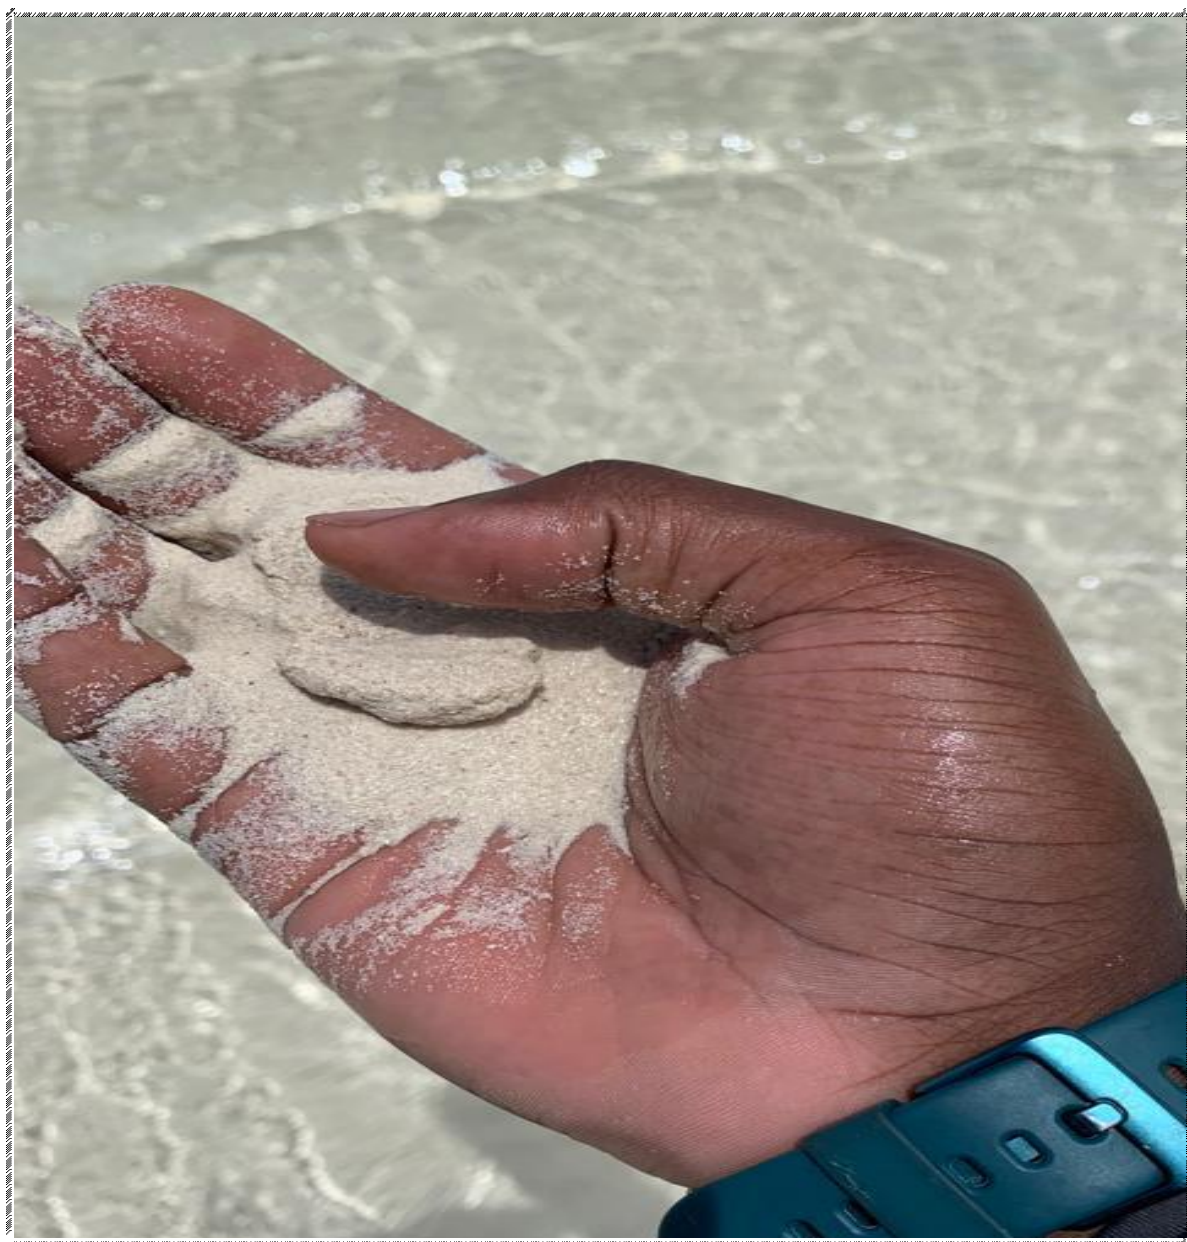
Figure 25: Visual inspection of sand sample collected at SS1.

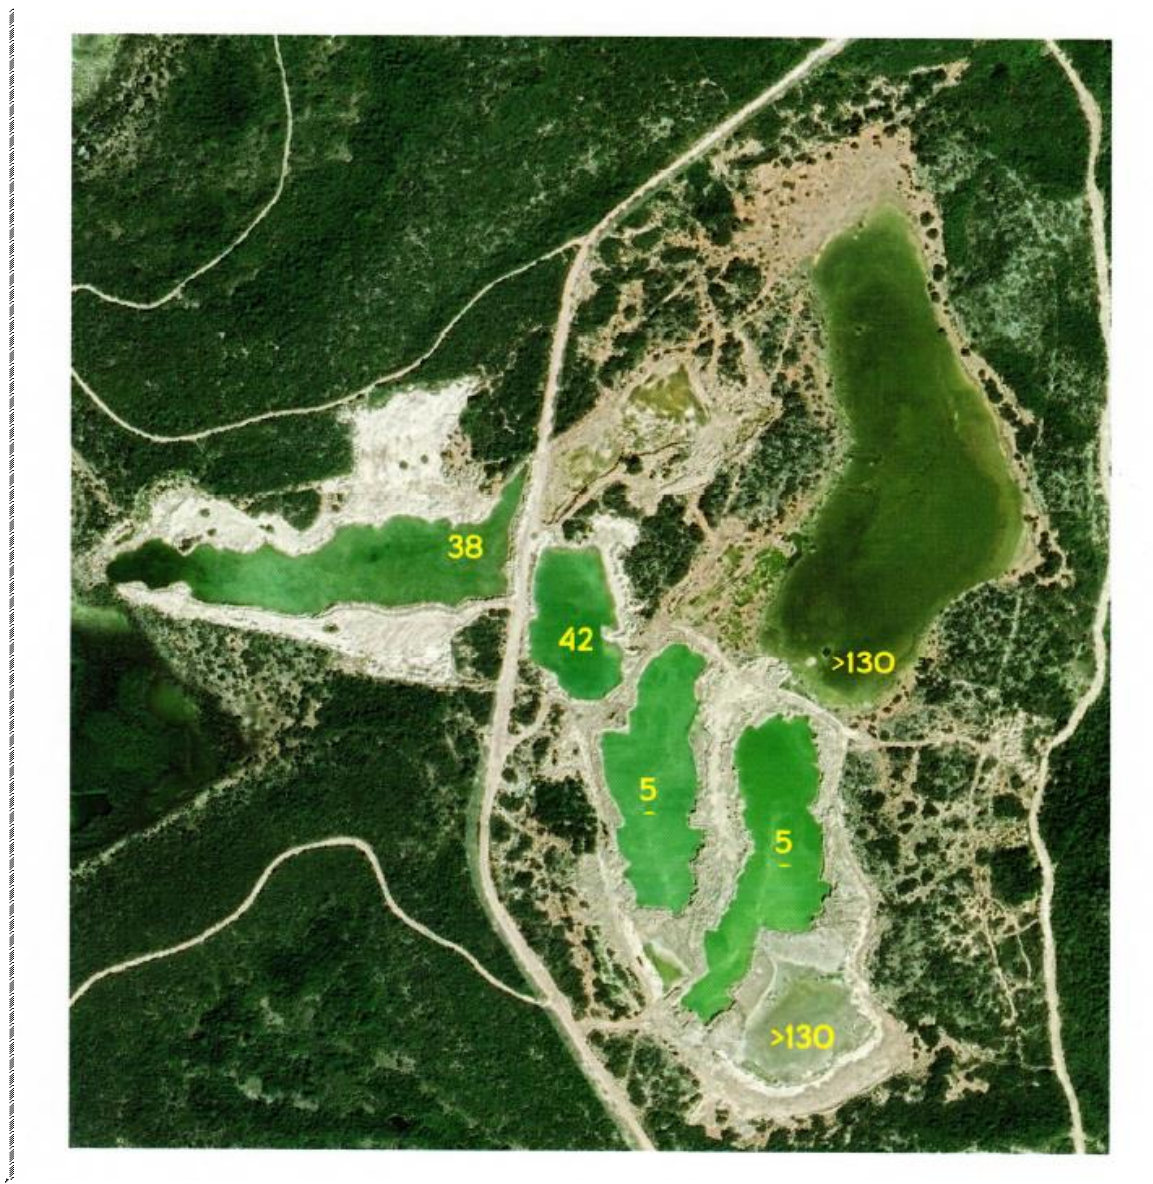
Figure 42: Salinity Measurements (parts per thousand) in natural man-made ponds at Sail Rock on April 23, 2022

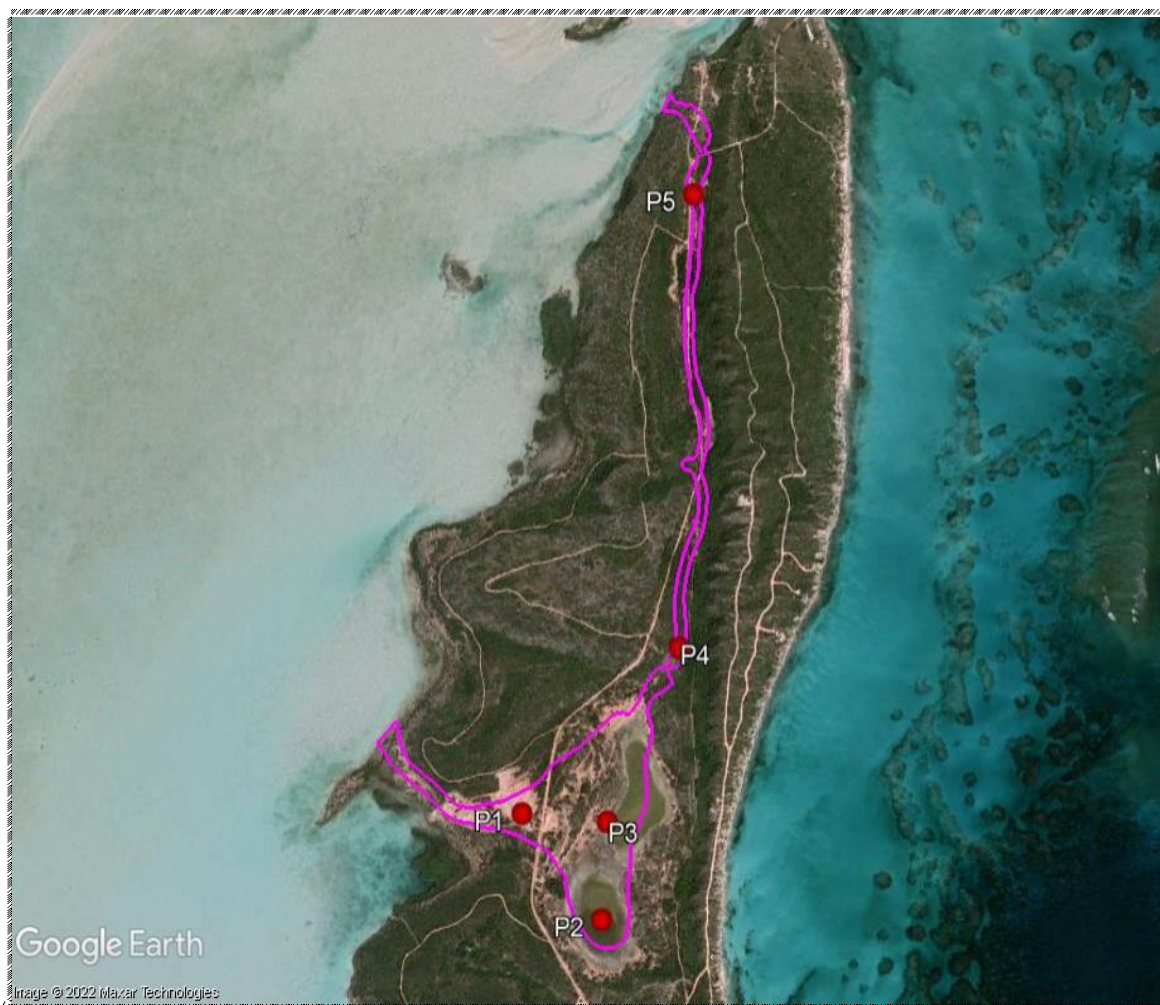
Figure 83: Pollutant concentration extraction points
