ST. REGIS

ENVIRONMENTAL IMPACT ASSESSMENT September 2023

Desarrollos Hotelco Wa, LTD

Prepared by: CDE-Graef

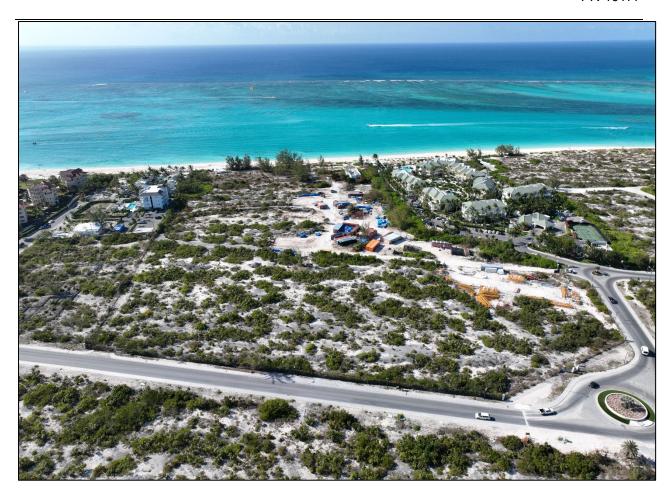
Figure 2-1 Existing Development and Site Conditions (March 2023)

The Project Area within the Grace Bay geographic and coastal environment is moderate to low in density and population as compared to the surrounding properties on Grace Bay. Sibonne and The Palms developments are located to the west and to the east, respectively. Adjoin the two (2) lots that comprise the proposed development property as one development.

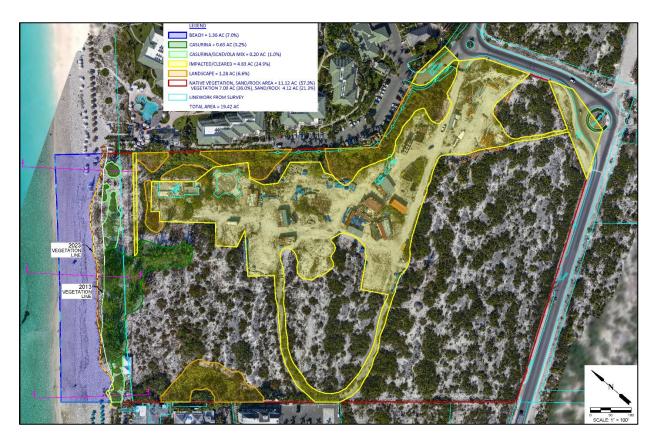
Figure 2-18 Terrestrial Biologic Communities

This environment is primarily undeveloped but does have recent disturbance from clearing activities related to storage of equipment and material. The landward edge of the dwarf coastal brush and upland coastal brush communities were located using Differential Global Positioning Satellites (DGPS) by Dial Cordy with assistance from CDE and Benchmark. Limits of other community types were photo-interpreted and ground truthed (Appendix D). A total of 8 temporary transects were surveyed in the upland habitat. Transects oriented perpendicular to each other and approximately 45° to the shoreline to cross the typically shore parallel terrestrial biologic habitat zones. A rapid ecological assessment method was used to assess general diversity, dominant species, habitat type, and vegetative structure.

Vegetative transition zones, changes in topography, and unique landforms were recorded on Project specific field forms and coordinates (X,Y) were collected. Vegetative transition zones were primarily identified by changes in growth forms and dominant species, recording the relative start and end points as observed in the field. Percent cover of the dominant species was

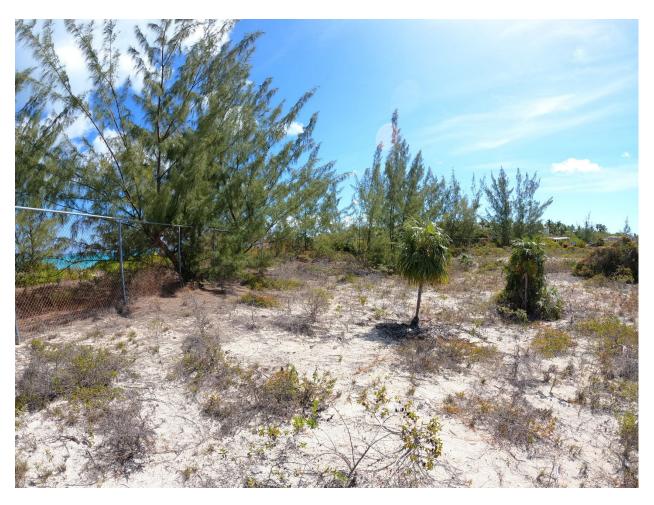
Figure 2-21 Coastal Mixed Shrubland

This community primarily comprises the backdune and is heavily influenced by drought and wind conditions. The vegetation is sparse, but where established is low growing anchored in the karst substrate. Progressing inland from the shoreline, the habitat shifts to primarily a mix of coastal scrub pioneer species that persist because of sporadic rainfall. This vegetative habitat occurs in shore parallel strips reflective of the underlying karst limestone geology. This community is

characterized by a variety of shrubs that occur throughout this habitat, Metopium toxiferum (poisonwood), Pilosocereus royenii (dildo cactus), and Jacquinia keyensis (joewood).

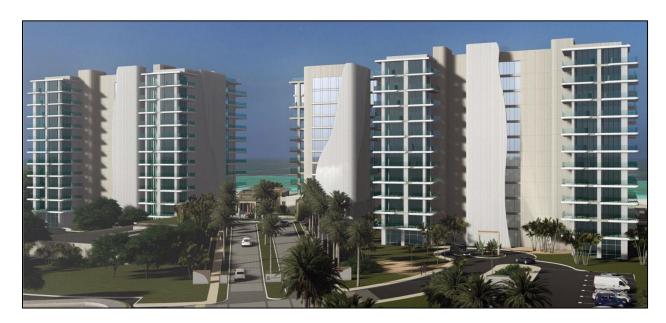
Figure 3-3 Residences

The St. Regis Development, Figure 3-3, consists of a Hotel, three Residence Towers, a Casino and associated utility facilities and will provide direct water access to Grace Bay. The Project site is currently undeveloped with no existing habitable structures onsite. This Project site is situated on Block 60905 and includes two (2) lots 198 and 199. Each lot is 8.58 acres for a total of 17.16 acres. The overall property development master plan provides for approximately 50% open and green space and amenities that include a fitness center, pools, spa, restaurant, parking, and all required logistics and maintenance facilities.

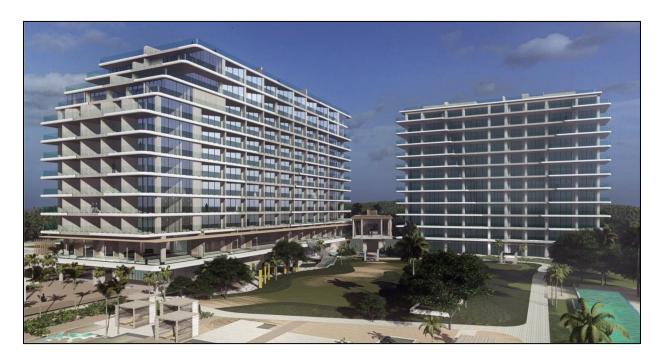
Figure 3-4 Hotel and Residences Pool and Beach Access

A single pool is proposed to be located adjacent to the restaurant and bar. The central location will provide access to the beach and, with several partitions, will create separated lounge areas. Just as with the restaurant, prevailing winds will provide a spectacular poolside experience (Figure 3-4). The property will provide a total of five pools with additional spas. Two pools, one each for families and adults, will serve primarily hotel guests, while each residential building will have a dedicated pool with deck and spa areas.

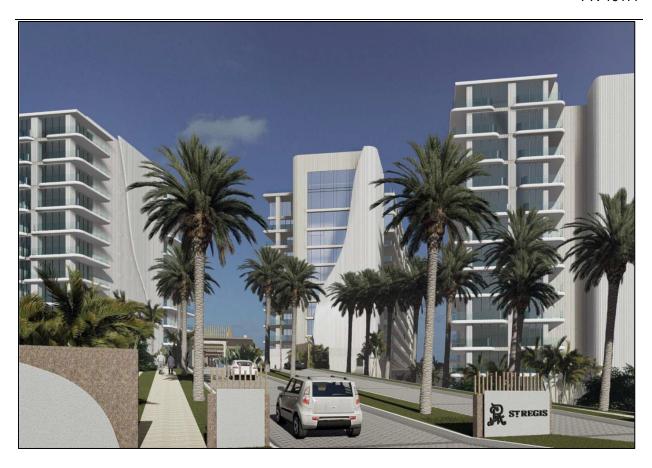
Figure 3-6 Typical Road and Parking Design Infrastructure

Improvements to infrastructure necessary to facilitate the operational phase of the Project are in discussion with companies supplying services to the development. Service upgrades will be provided as necessary. These elements will provide St. Regis with a vacation and residential experience consistent with, or exceeding, luxury, high end properties on Providenciales, (Figure 3-6).

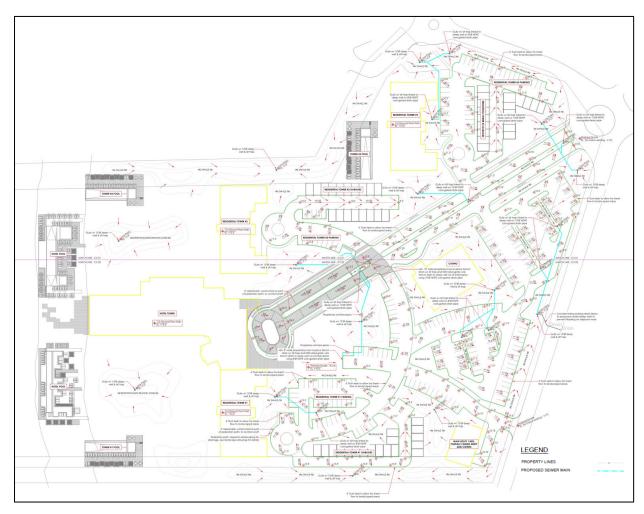
Figure 3-8 Wastewater Treatment and Collection System Design

The most efficient, technically, and economically viable option is the use of a single Wastewater Treatment Plant (WWTP) facility (propriety design) for the St. Regis Development (Figure 3-8). This has the advantage of being managed and controlled centrally, and has the least potential impact on the environment, and will produce significant enough volumes of effluent that will be treated and used as water for irrigation. A maximum of approximately 15,000 Gallons per Day (GPD) of grey water is anticipated to be available for irrigation purposes at full occupancy.

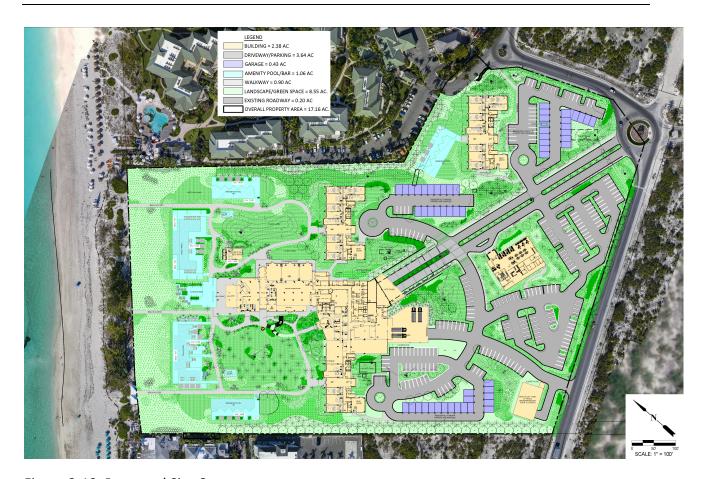
Figure 3-13 Proposed Site Coverage
